## AP Inspections LLC

Report Number  
**INS-2026-0010**  
3/1/2026

**9480 east 200 north**  
Fremont, IN 46737

Inspection Date: 3/1/2026

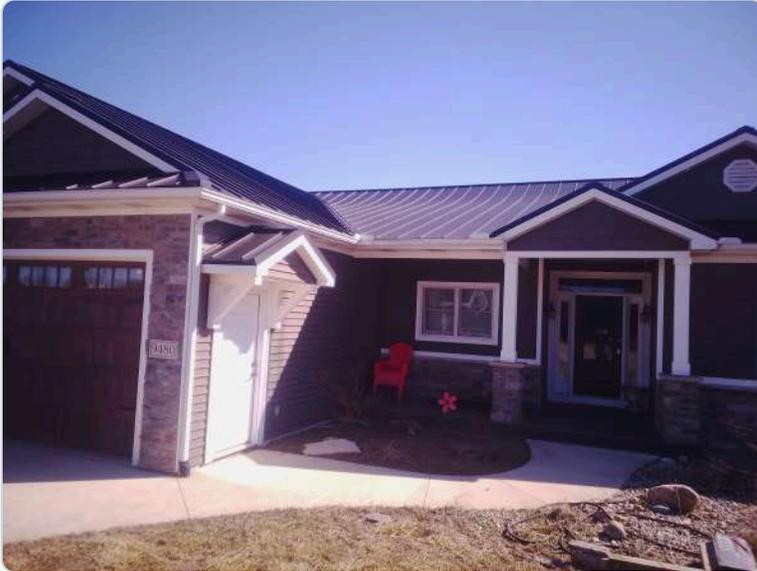
Metal.

8 years old. Looked at from ground.

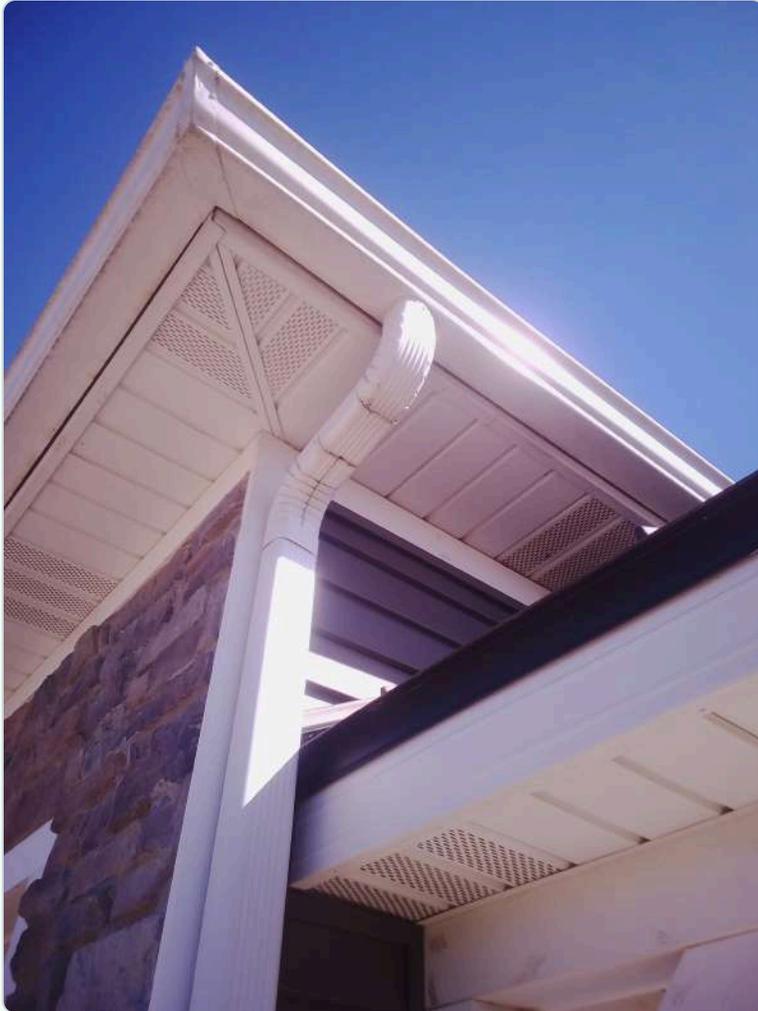
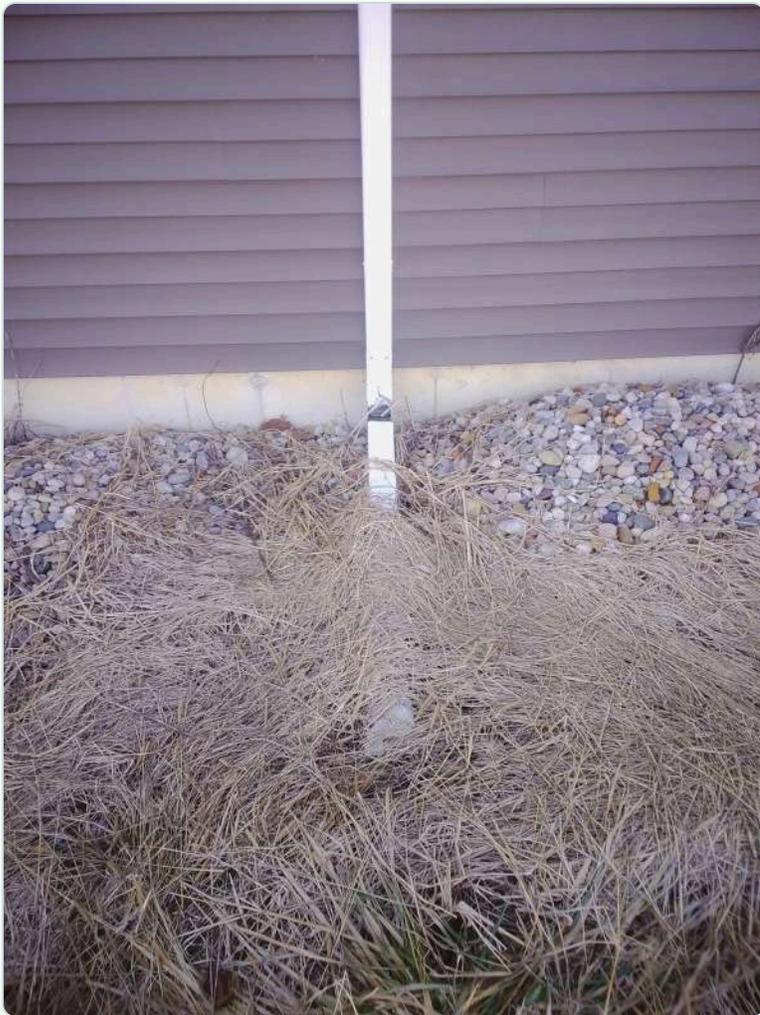
Underground drainage

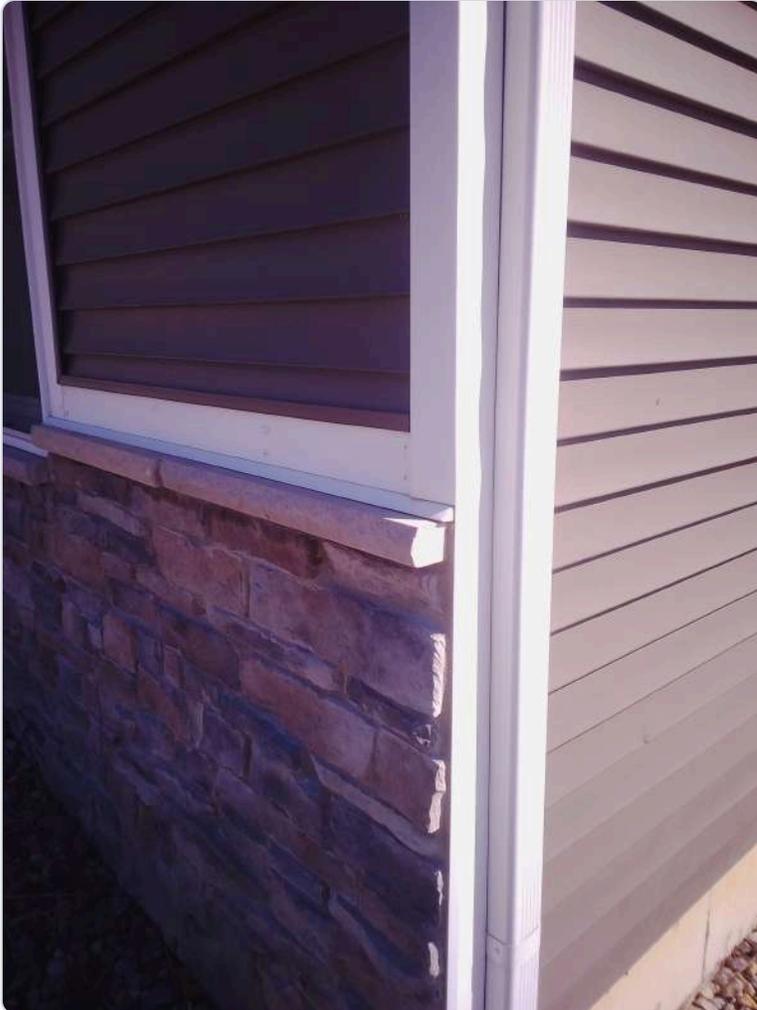
Vinyl siding with real brick facade.

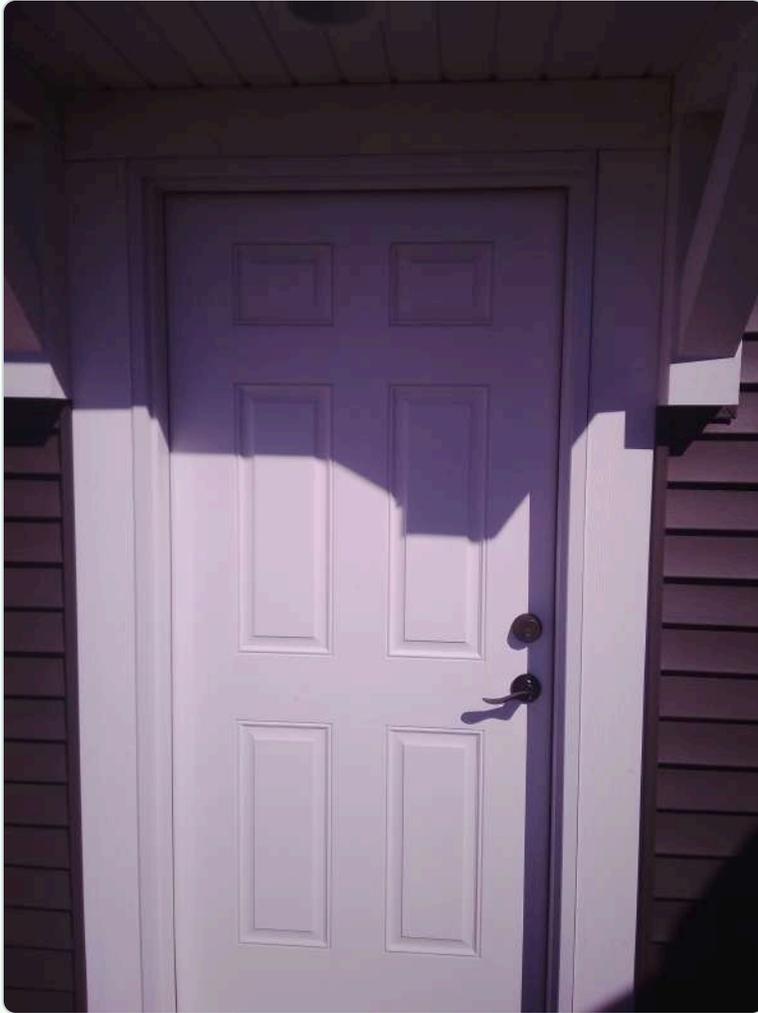
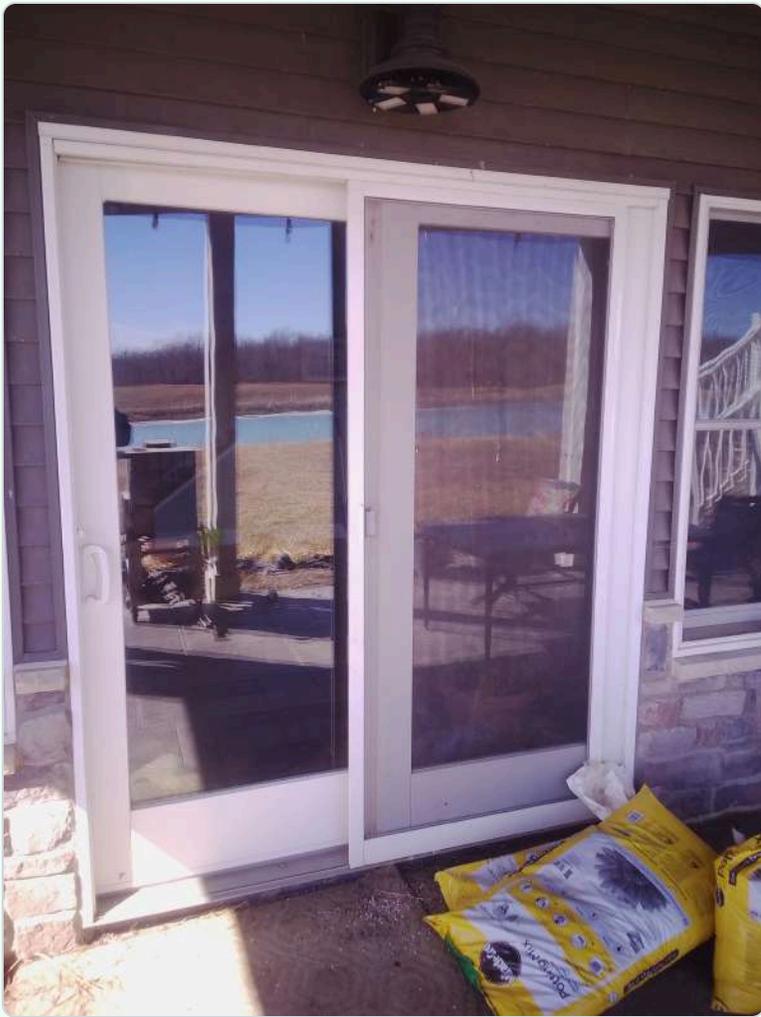
All doors fit snug and close and open properly

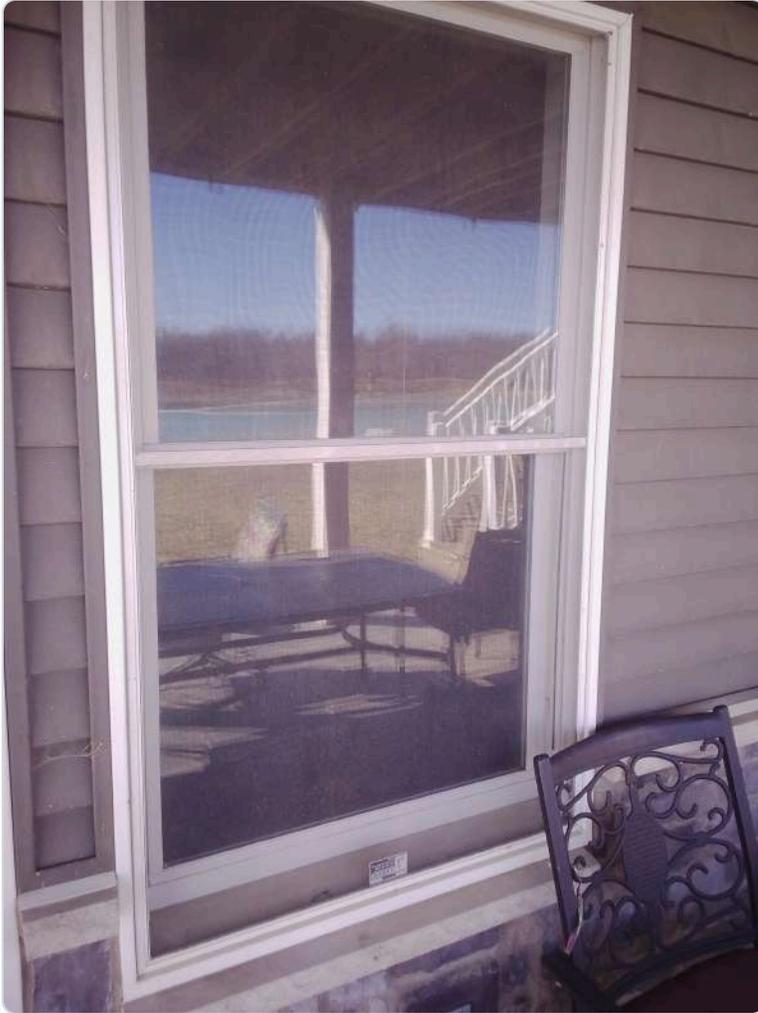
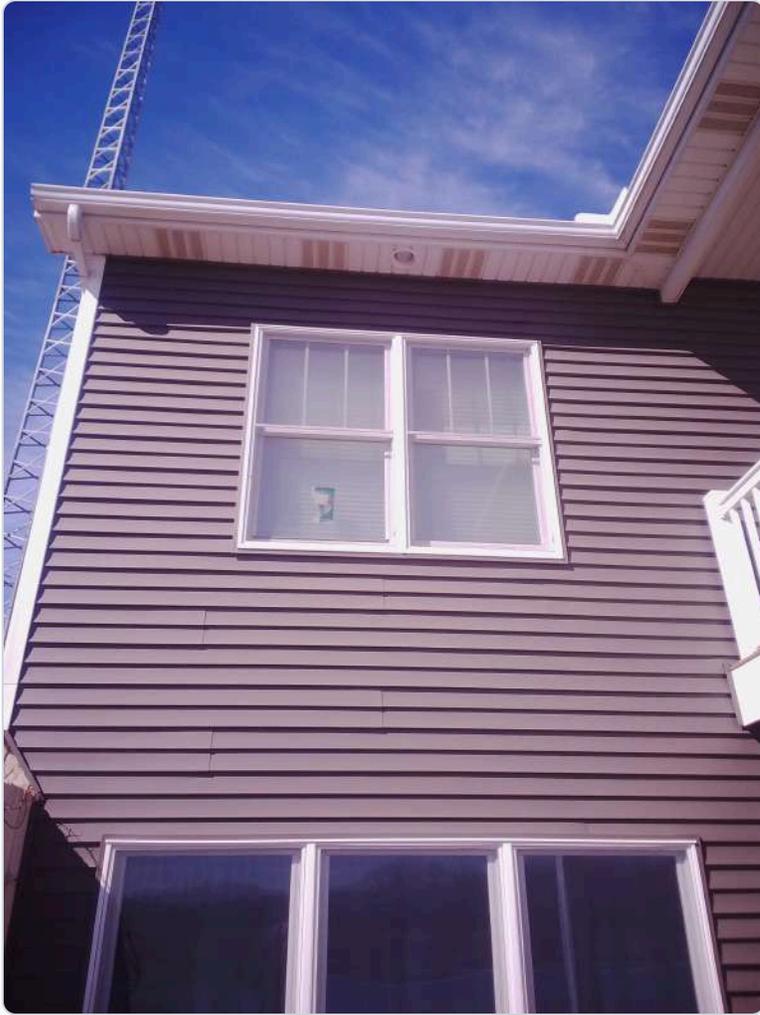
Windows are double hung and open and close properly

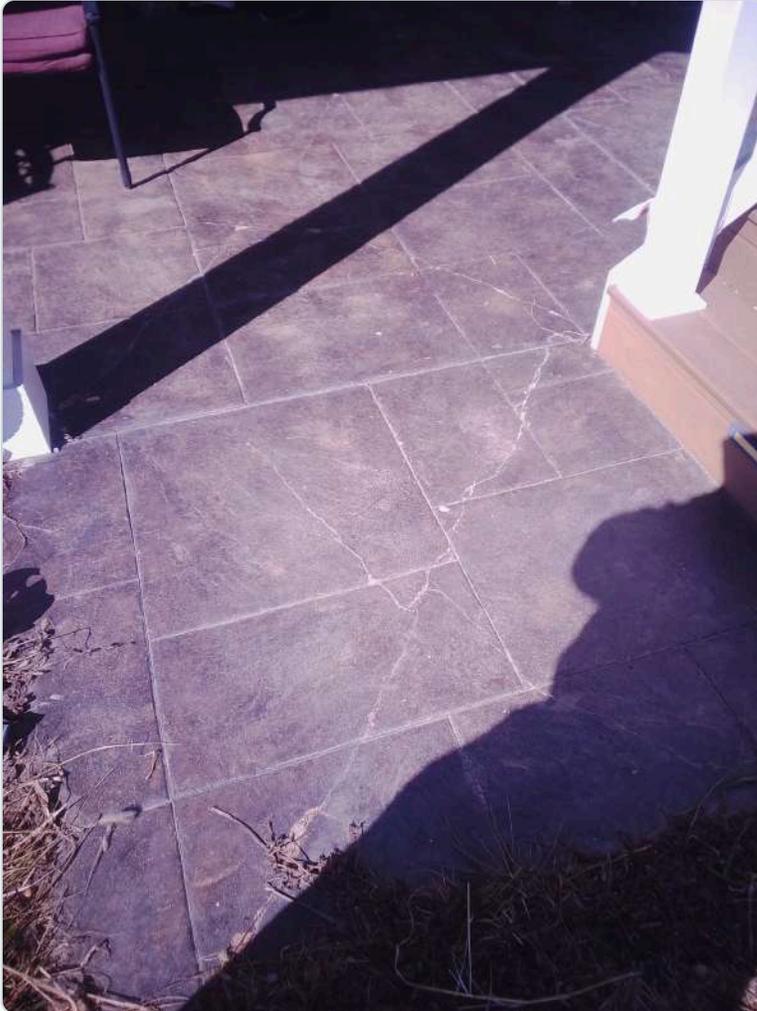
Driveway is gravel sidewalks are concrete, patio is concrete stamped

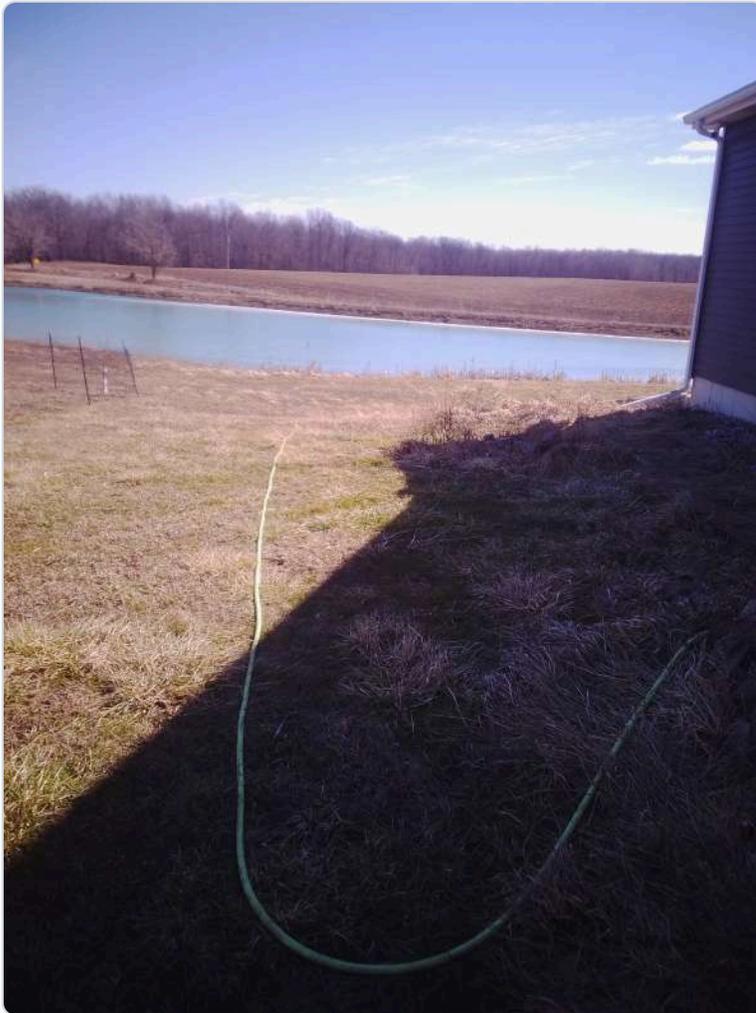
All drainage runs toward pond away from House

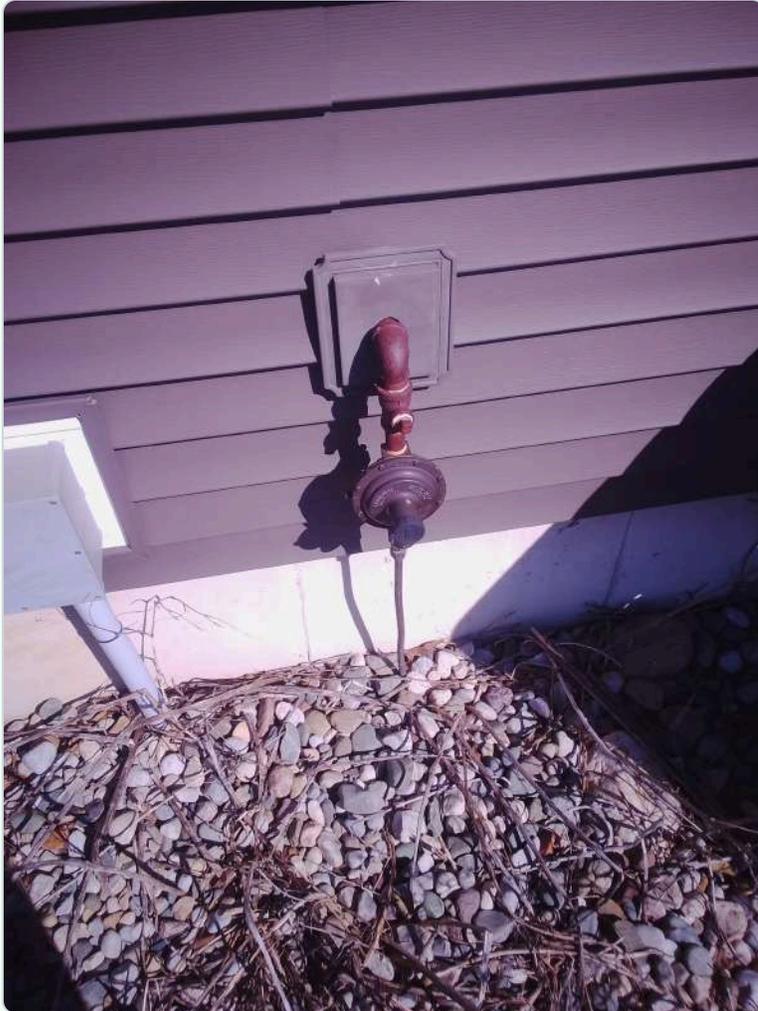
Underground propane tank. Piped into house. Shut off located west side of house.

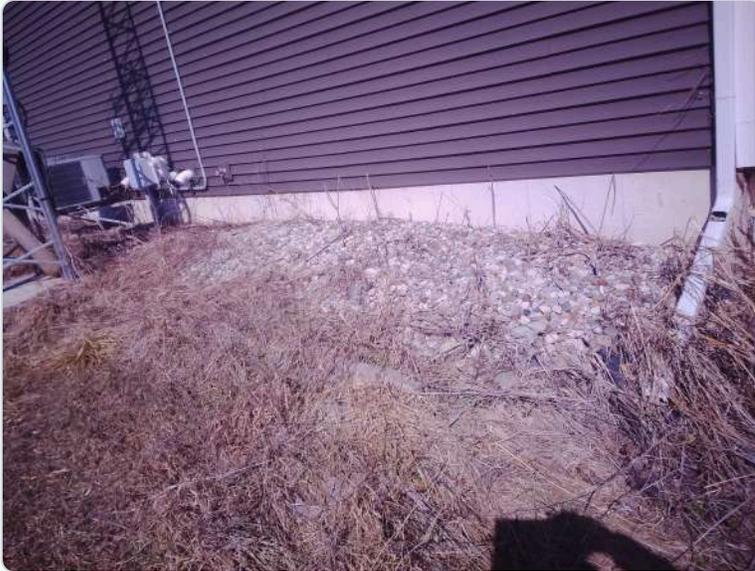
Foundations concrete with a basement

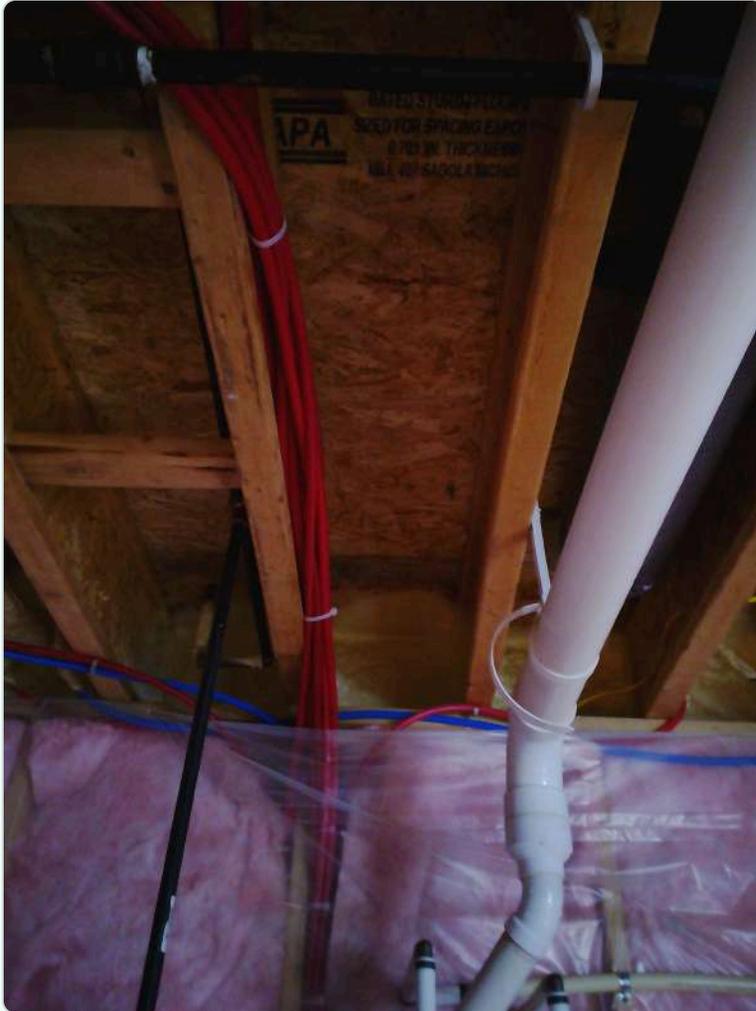
OSB flooring with I joist

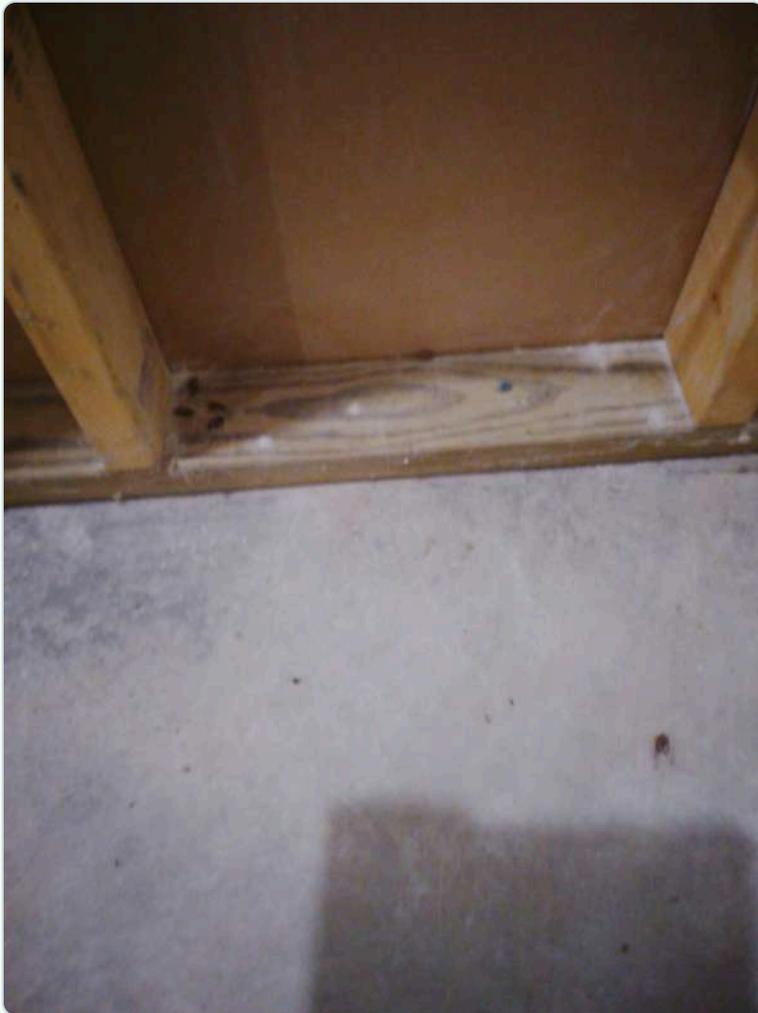
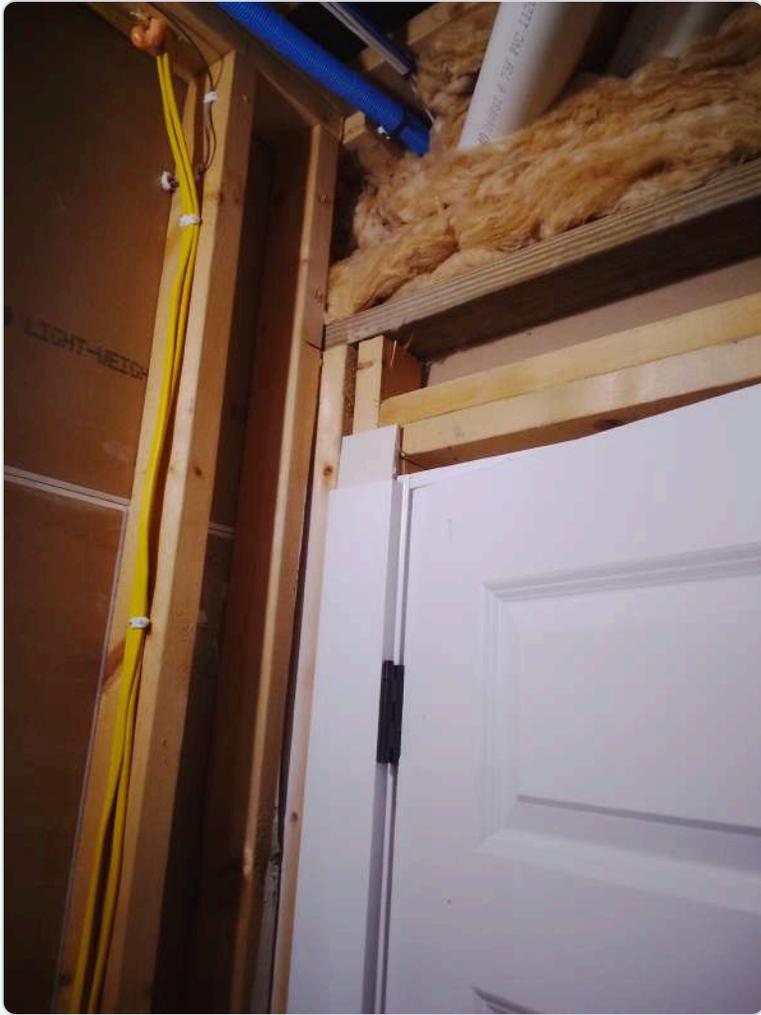
2x4 studs with seal plate treated and drywalled

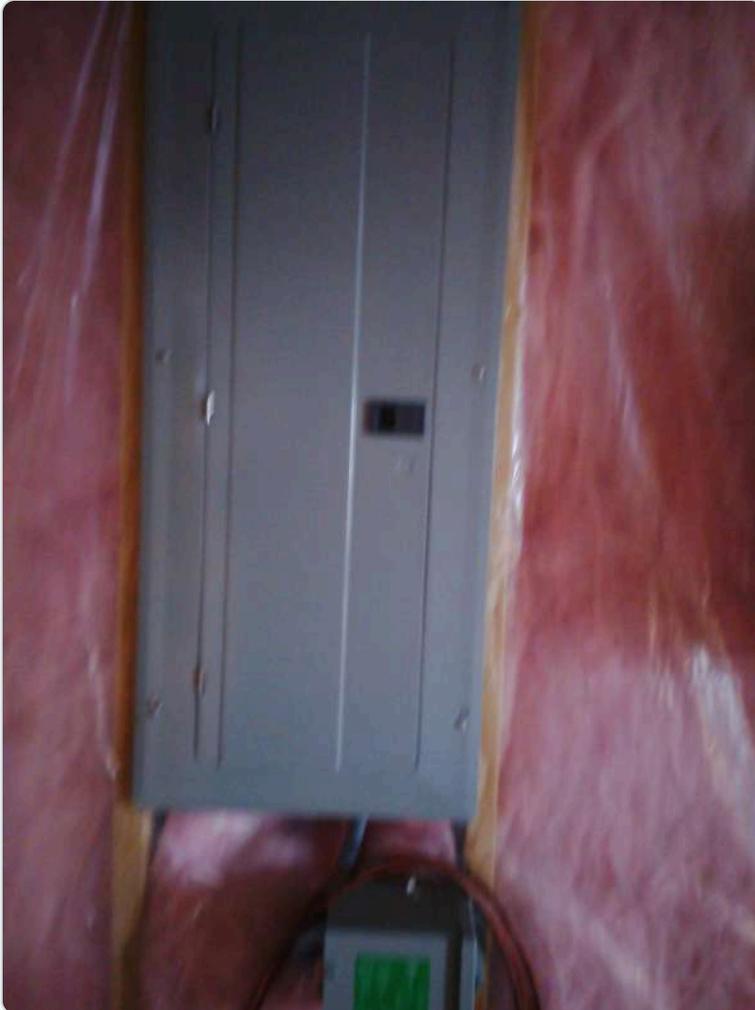
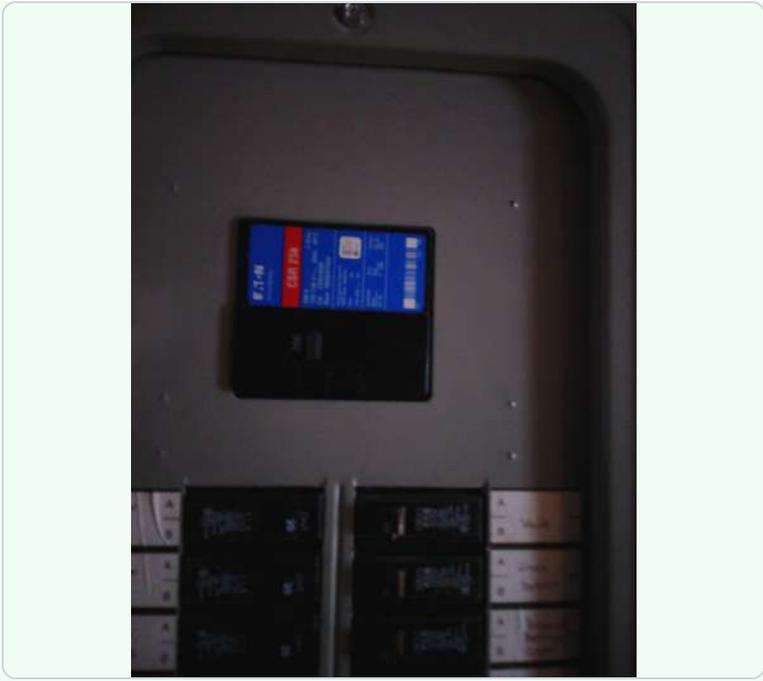
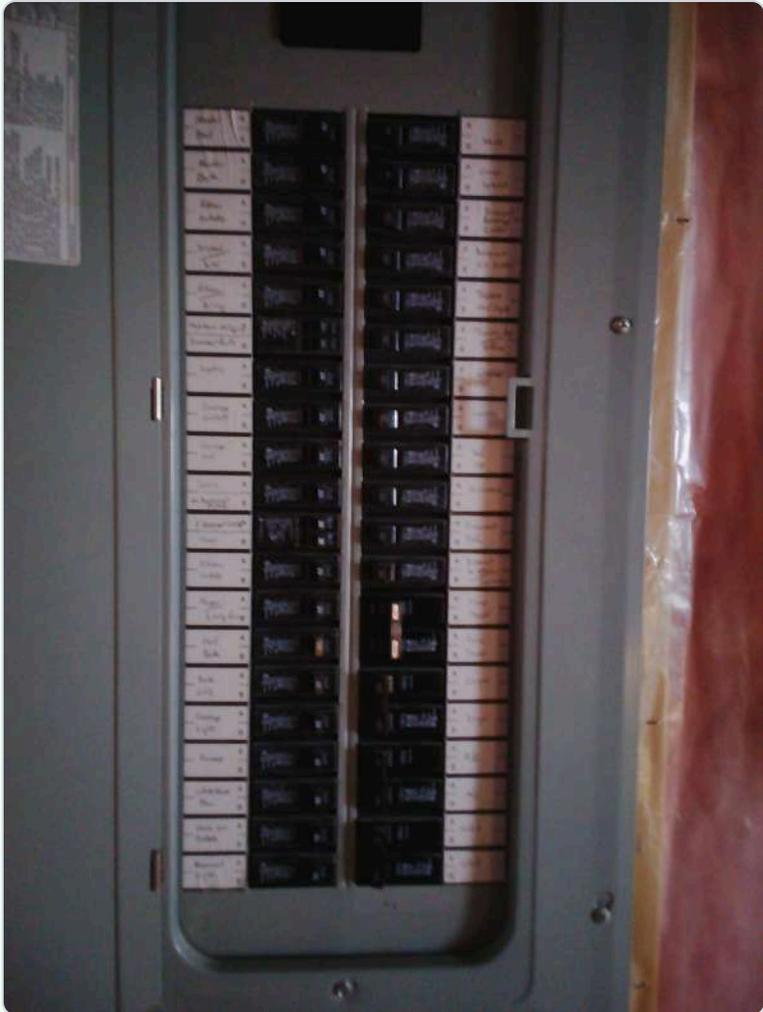
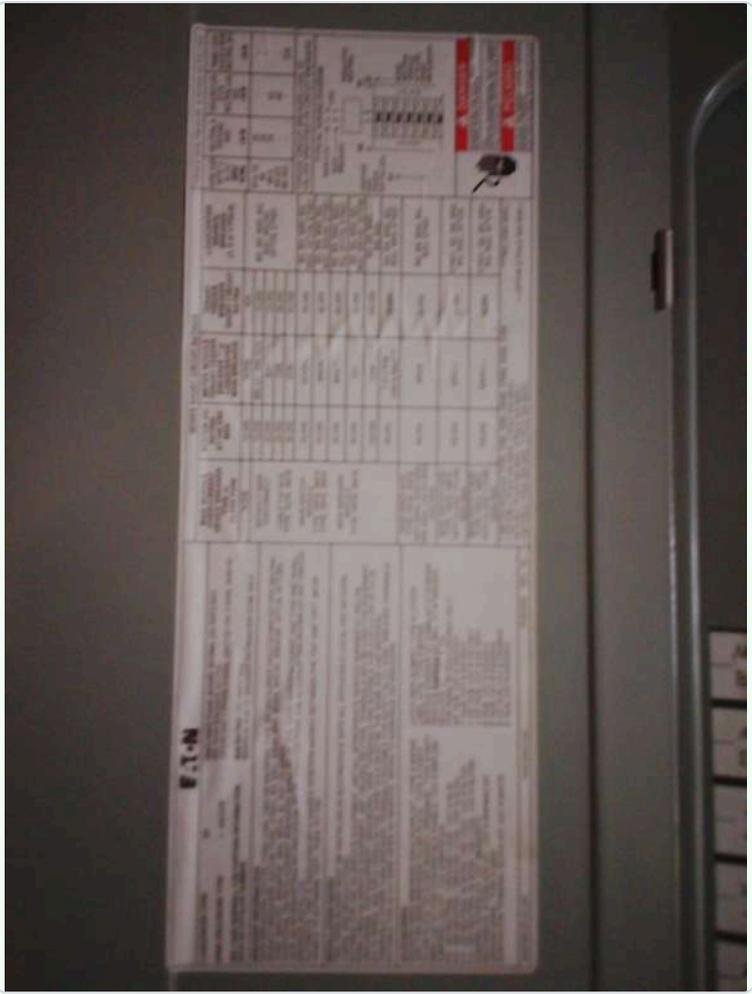
Located in basement in utility room

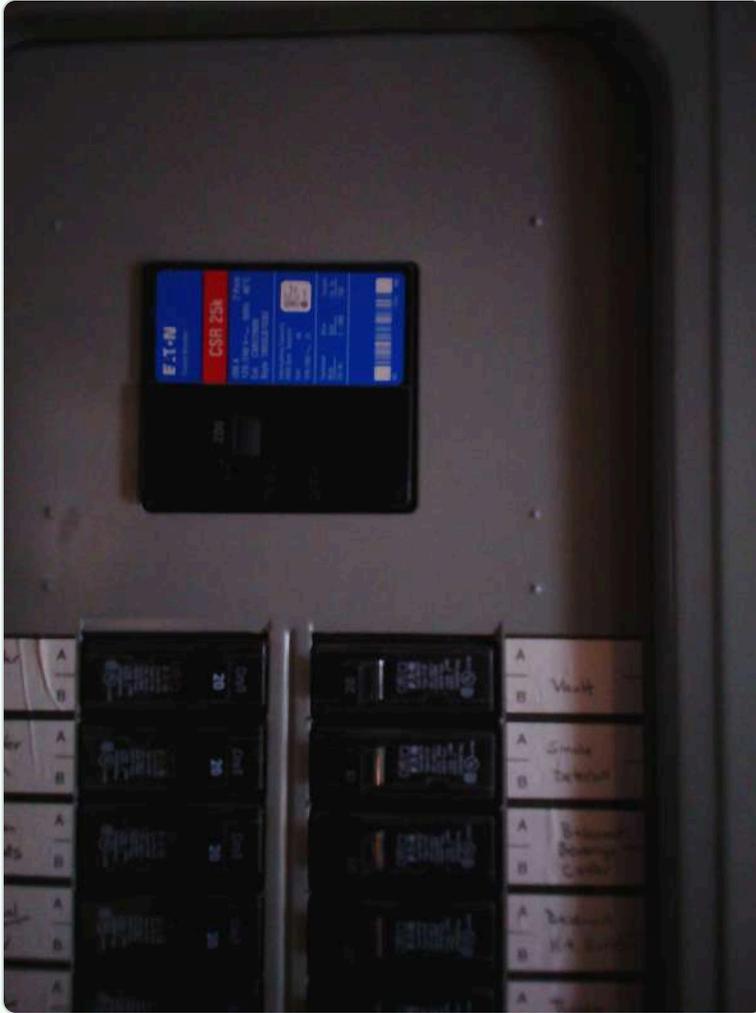
Eaton, 200 amp service

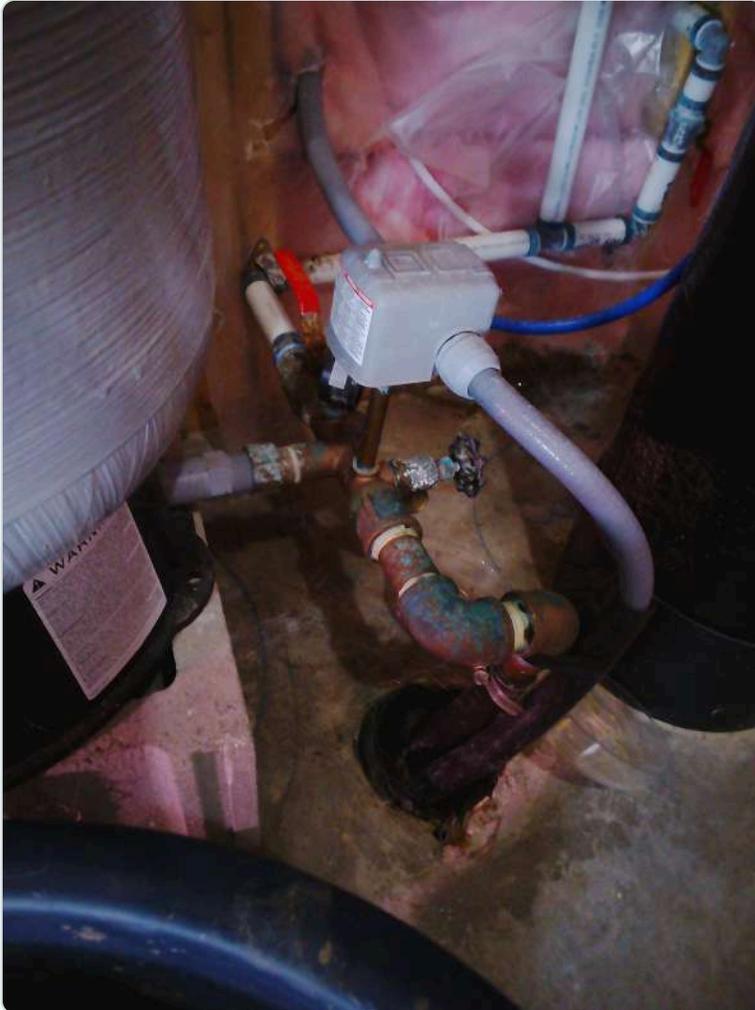
3/4 in connection PVC plastic to brass fitting

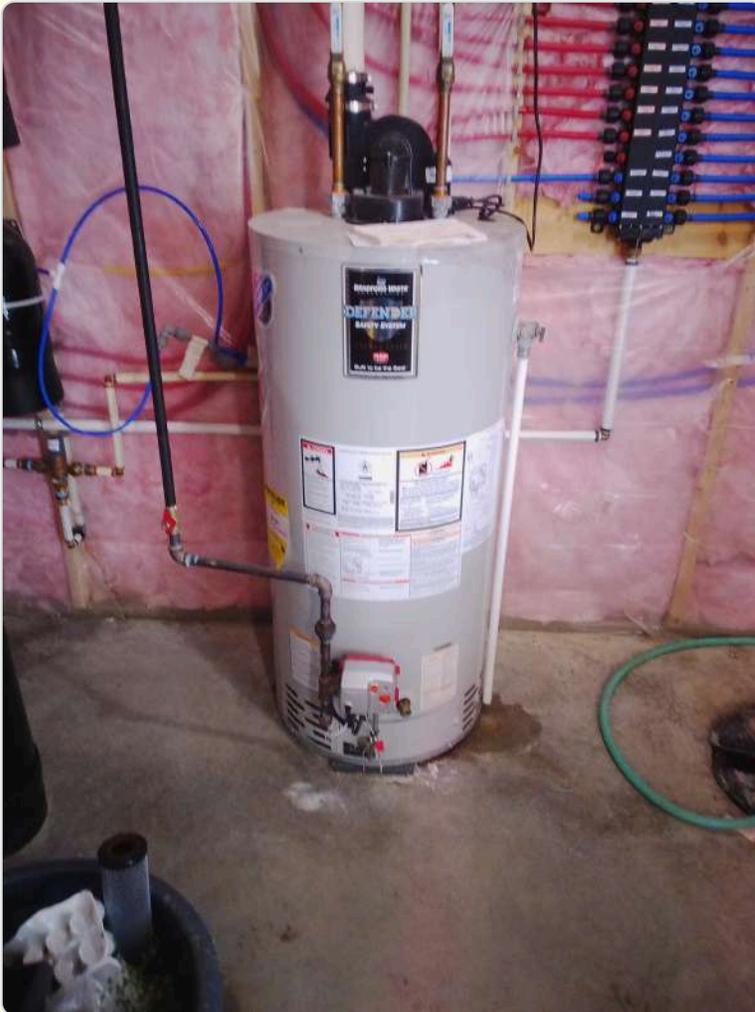
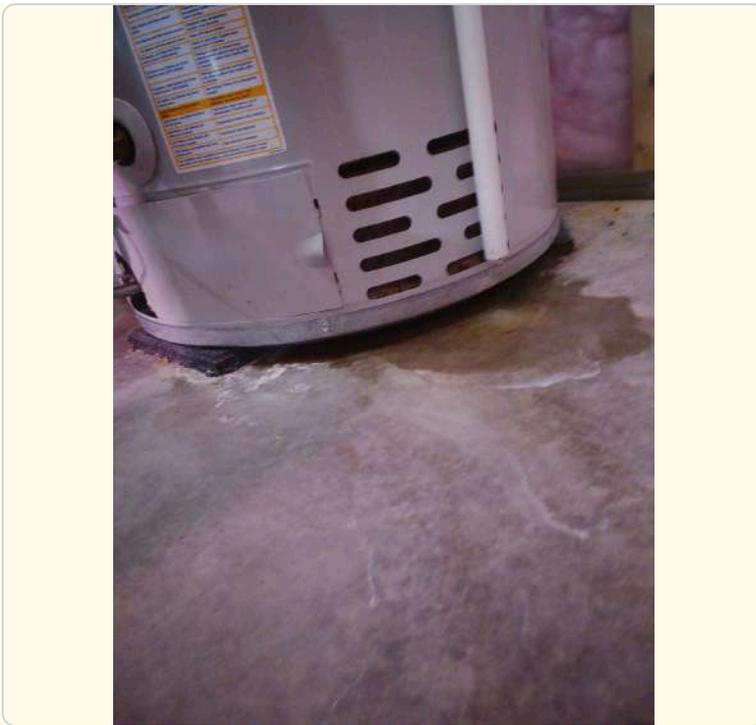
Puddle of water under trap drain valve

Recommend a qualified plumber evaluate the water heater's drain valve for leaks or damage. Prompt inspection and repair are advised to prevent potential water damage and ensure proper operation.

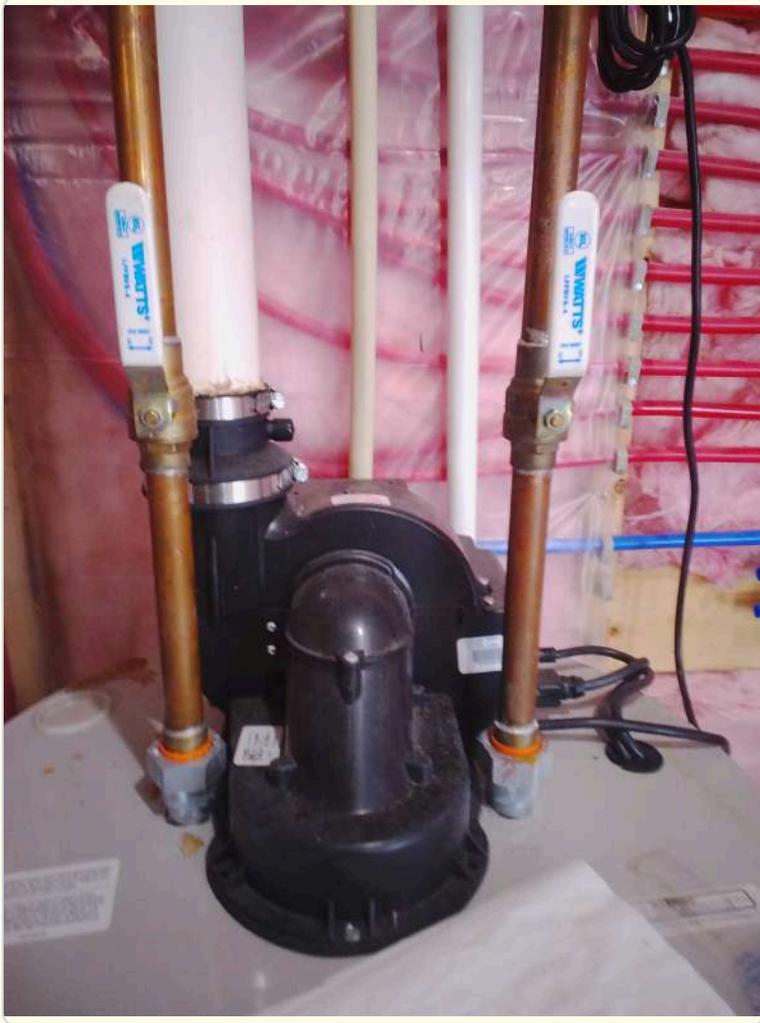
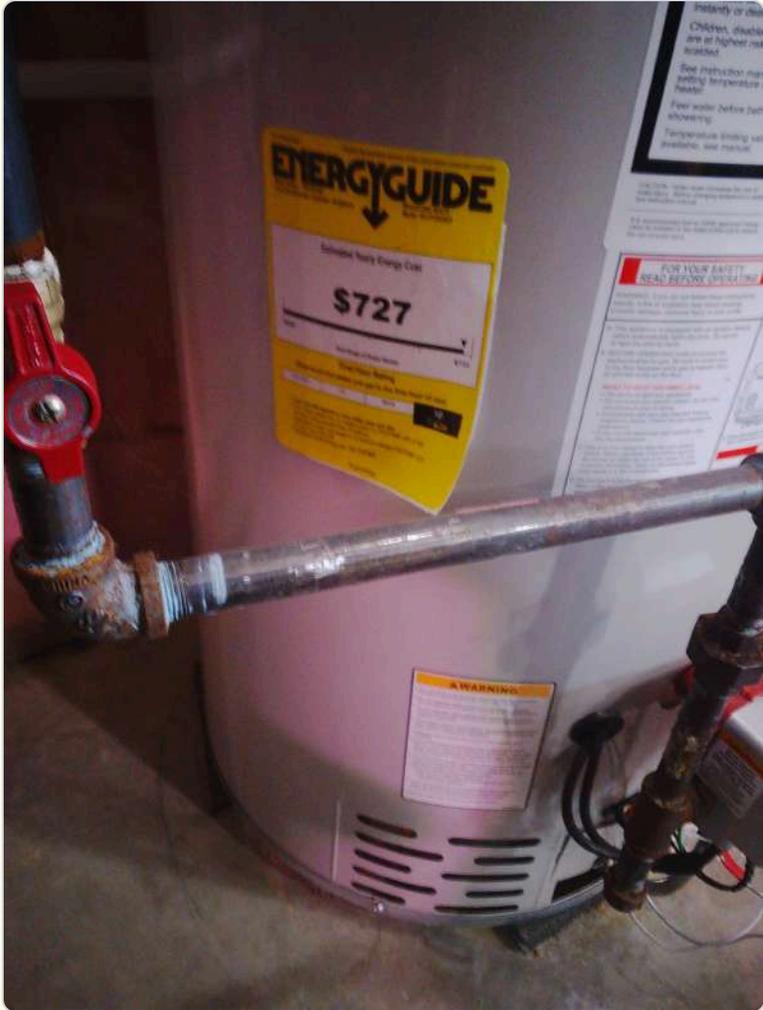
No restraints visible trp valve leaks

Recommend a qualified plumber evaluate the water heater restraints to ensure proper installation and safety. Additionally, have a professional inspect the temperature and pressure relief (TRP) valve for leaks or signs of malfunction.

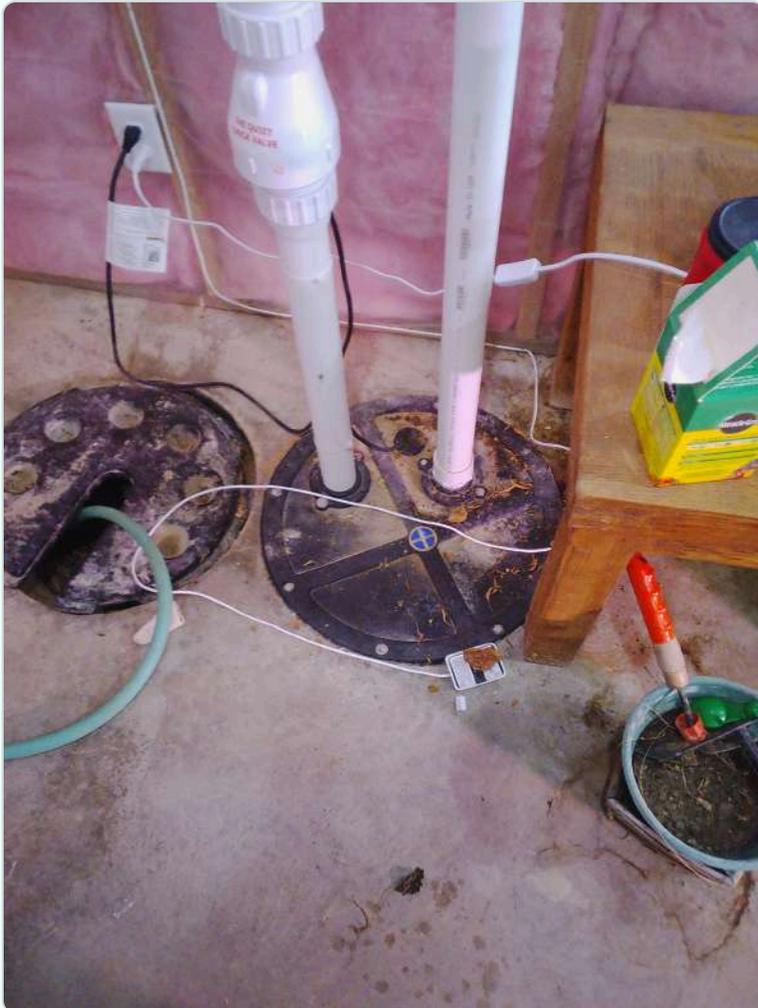
All drain and waste go into grinder pump, vent system is through the roof and outside of house

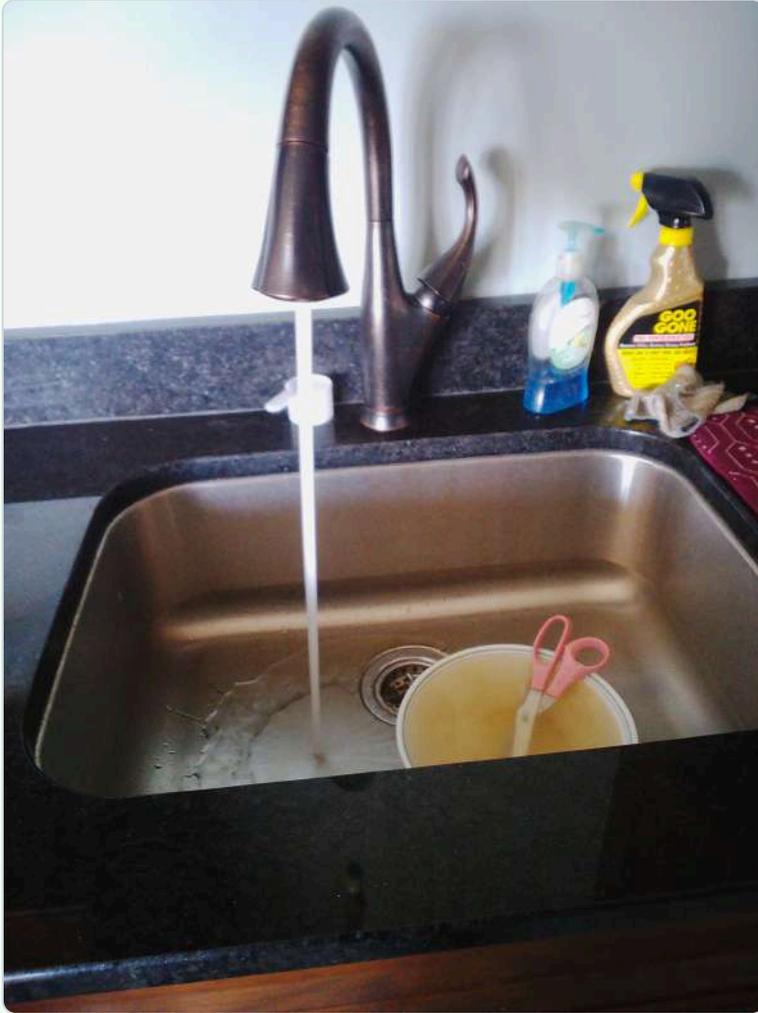
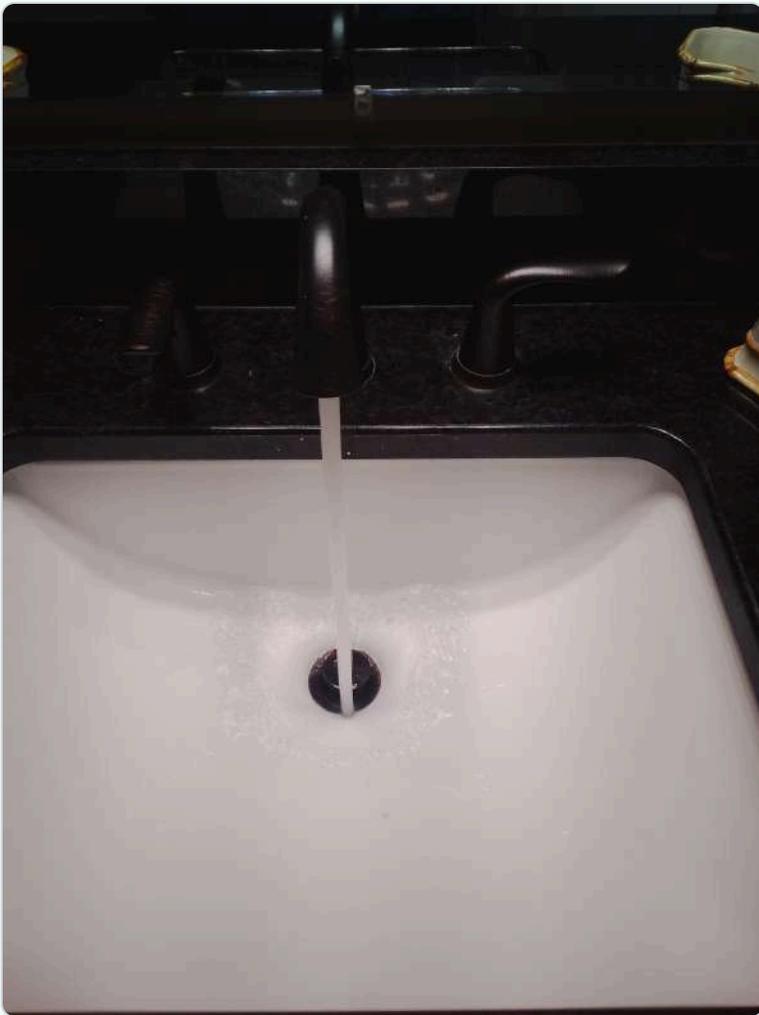
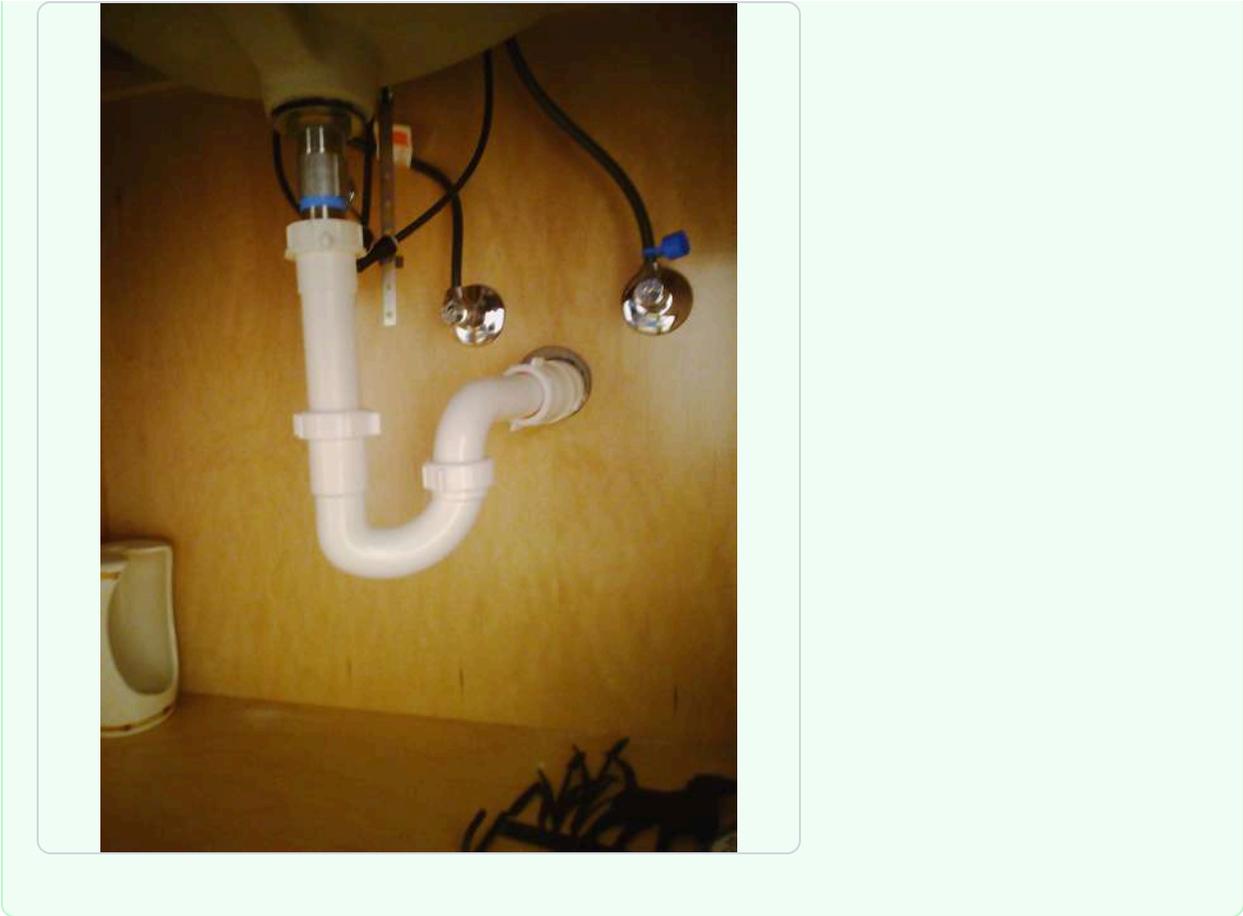
All fixtures work good condition and properly

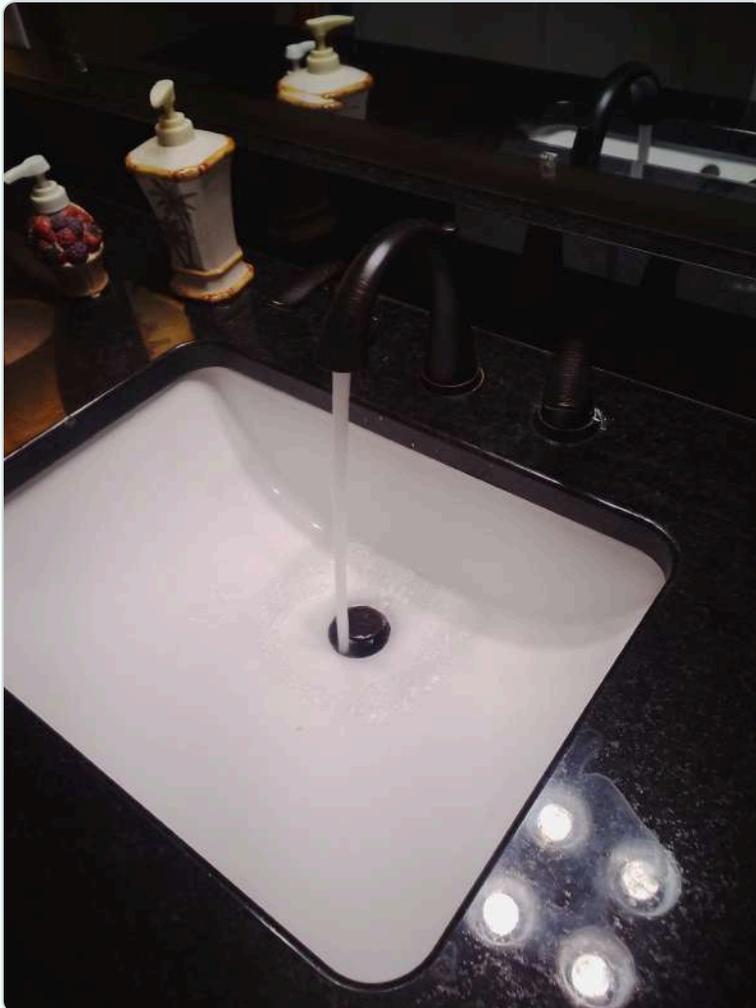
Functional flow test good

Functional drain test good

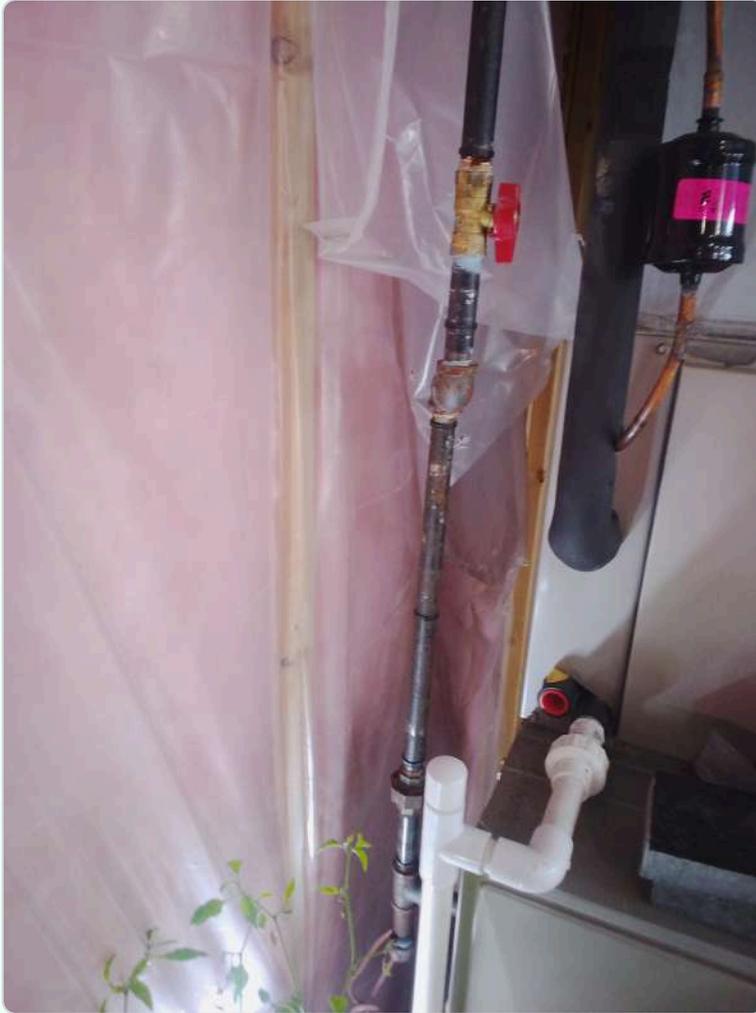
All fuel propane piping looks good no rust with shut off valves
