## AP Inspections LLC

Report Number  
**INS-2026-0010**  
3/1/2026

**9480 east 200 north**  
Fremont, IN 46737

Inspection Date: 3/1/2026

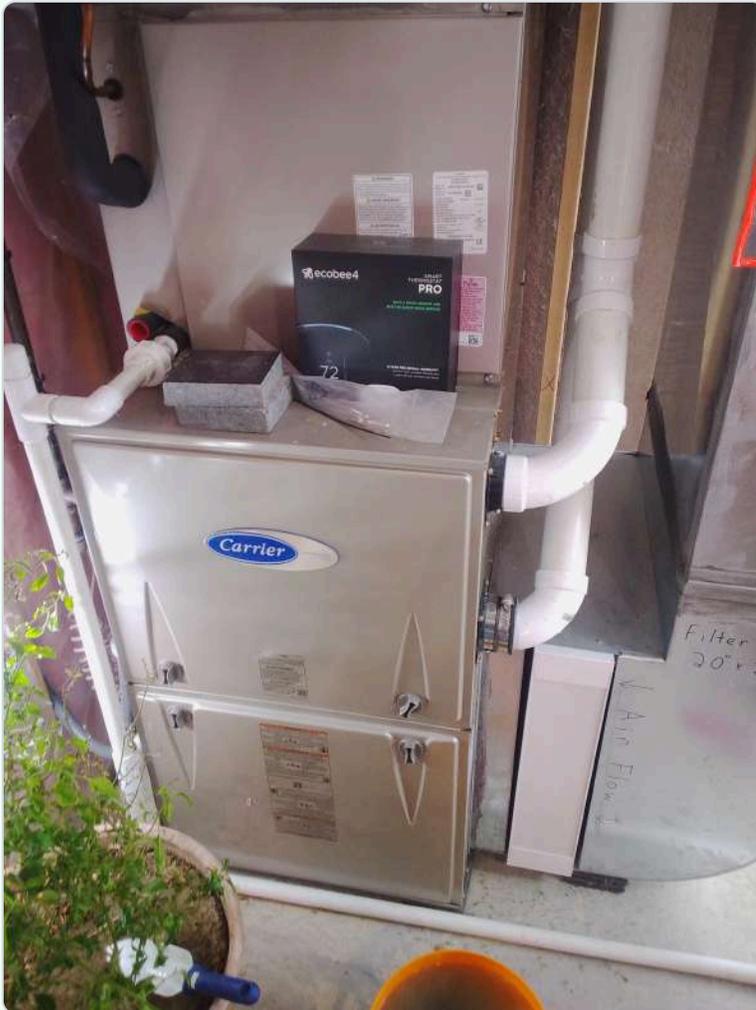
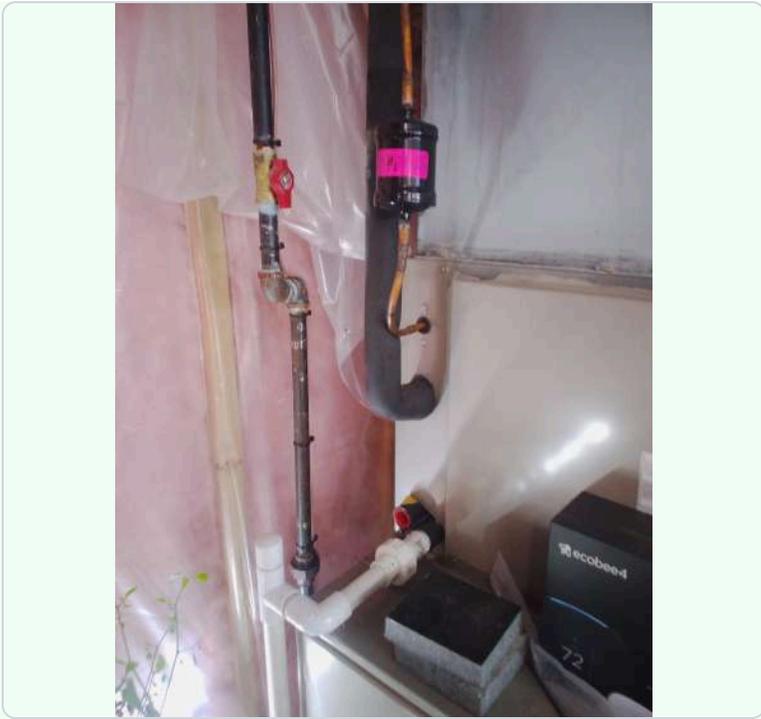
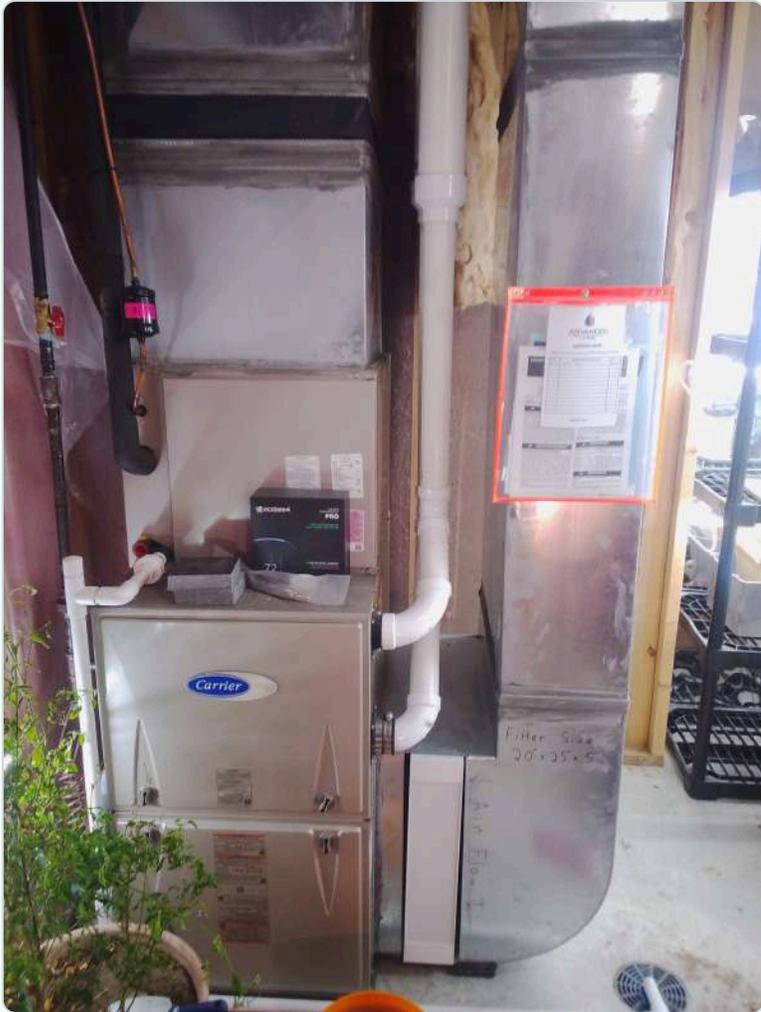
Propane gas fed furnace with forced air.

Carbon monoxide tested nothing found around unit.

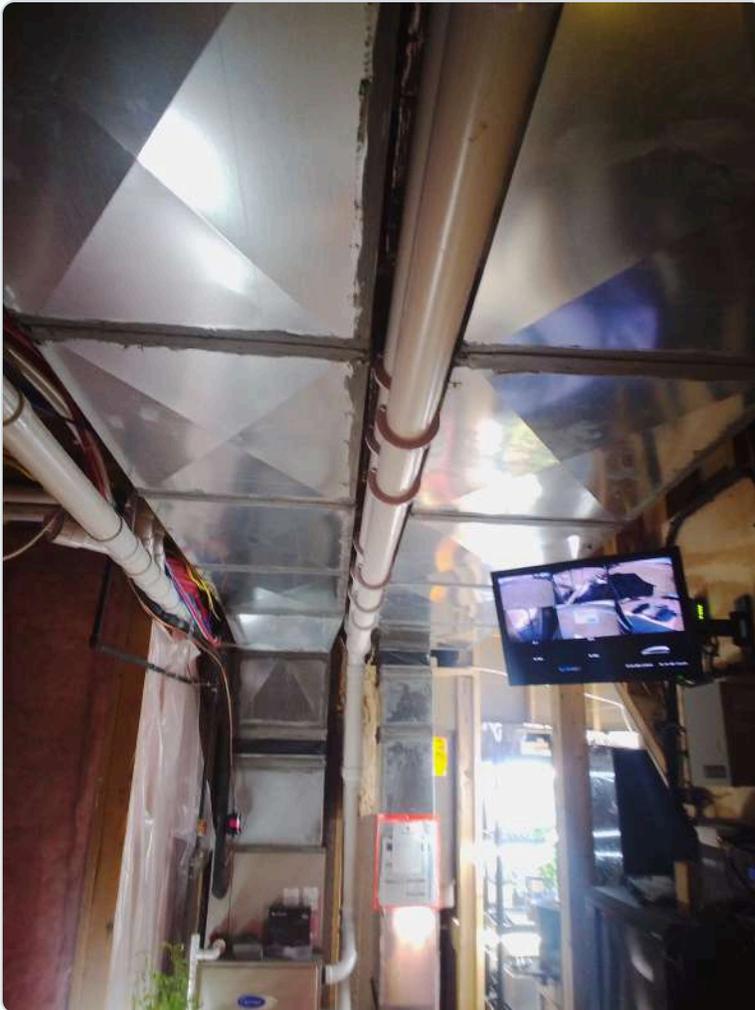
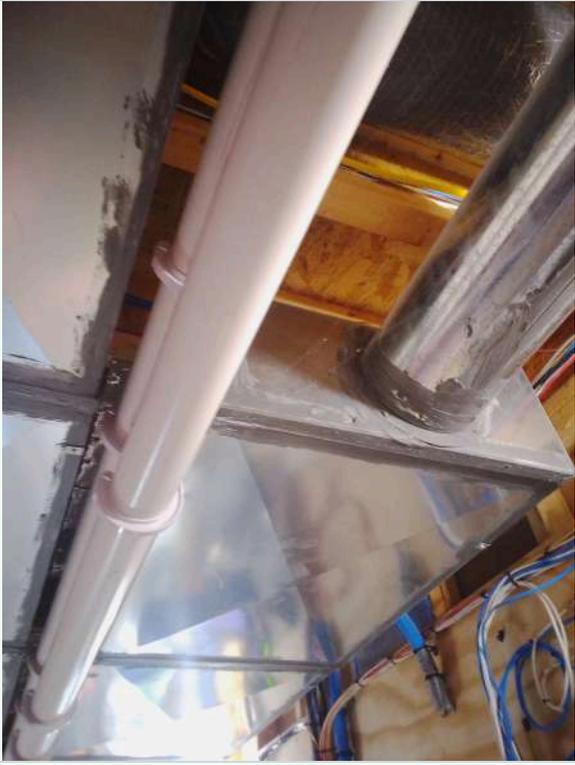
All ductwork in venting looks good. All vents lead to west side of house by air conditioner only bathroom vents is vented through the roof

No immediate issues were observed with the ductwork and venting system. It is recommended to periodically inspect vents for proper operation and ensure roof vents remain clear of obstructions to maintain optimal airflow.

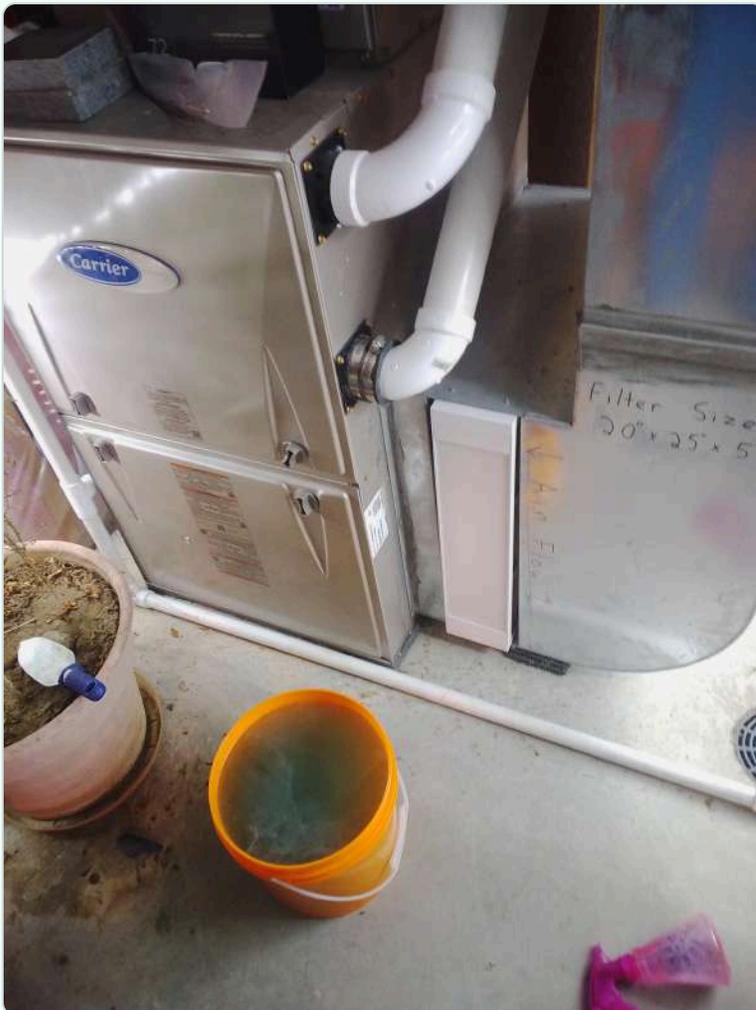
All air filters look good clean free of debris

Put date on air filters of wind changed and change air filters one to three months.

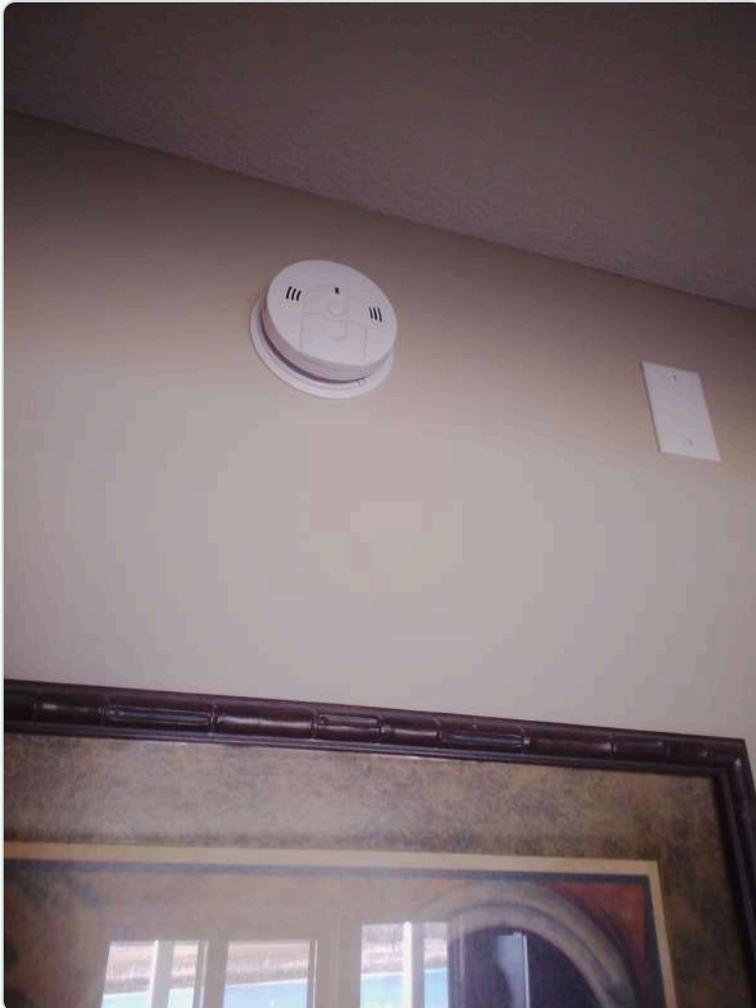
Combination smoke detector and carbon monoxide tested throughout the house no Co found.

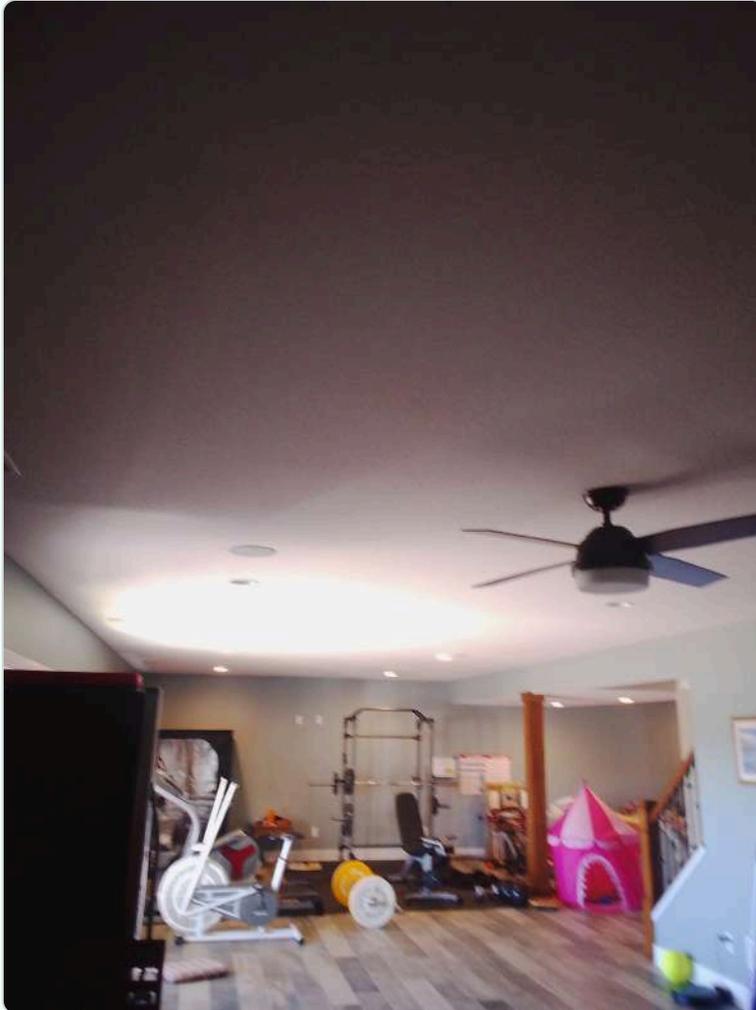
No cracks found all in good condition

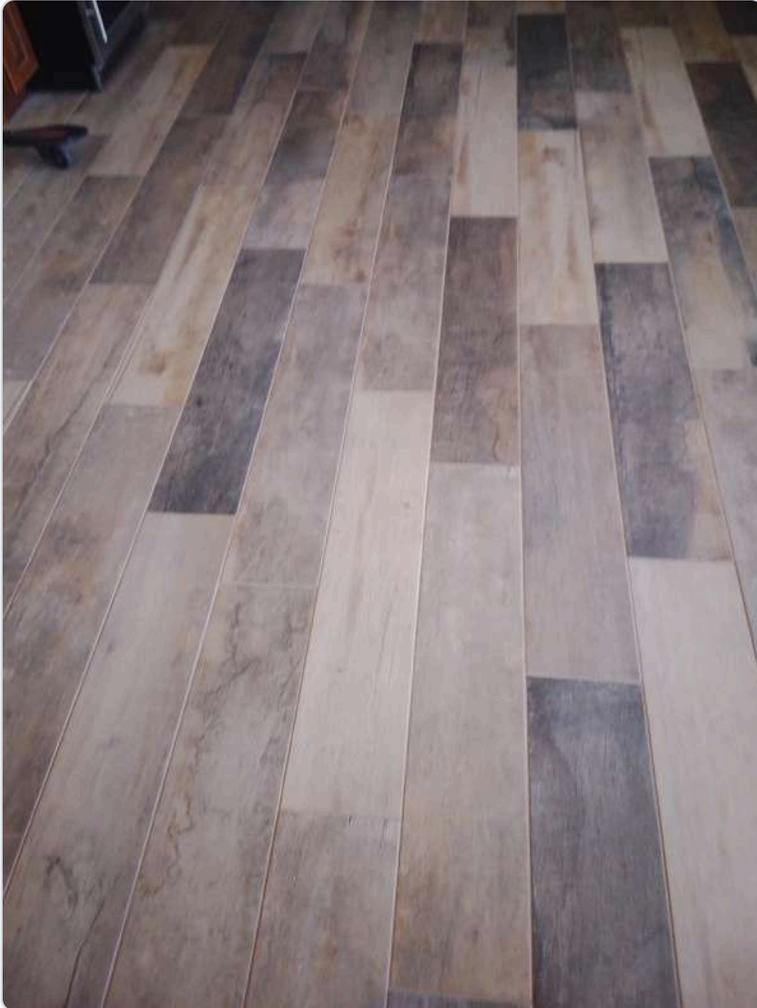
All floors good condition no defects the basement has concrete floor with laminate flooring good condition

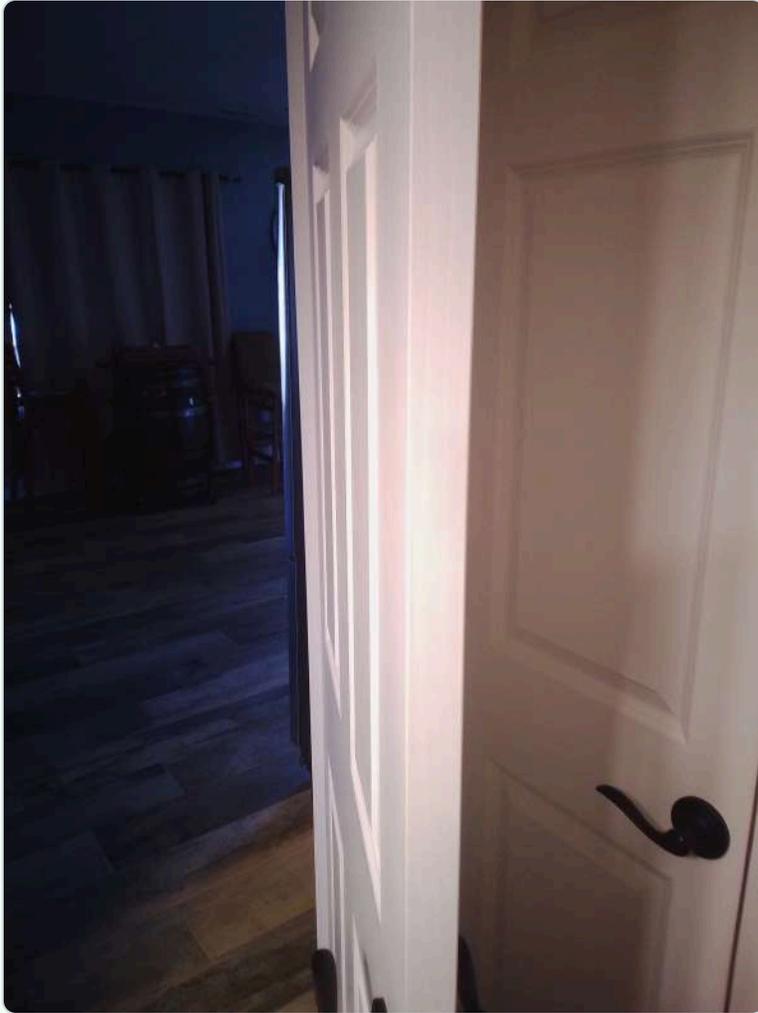
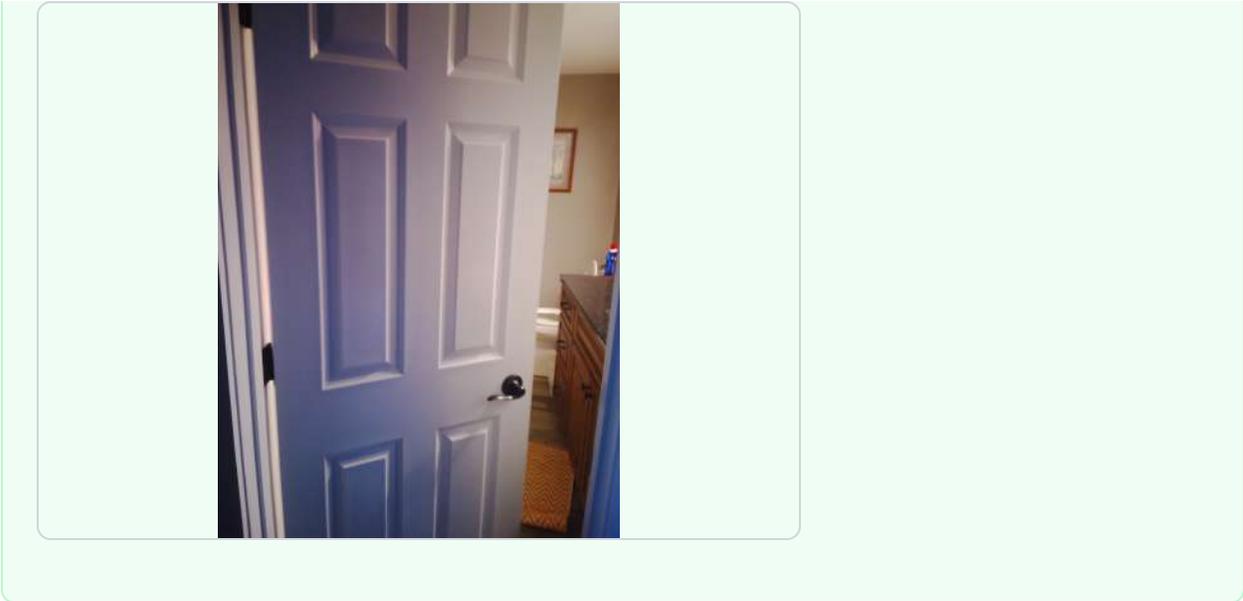
All interior doors are wood, and a good condition close and open properly

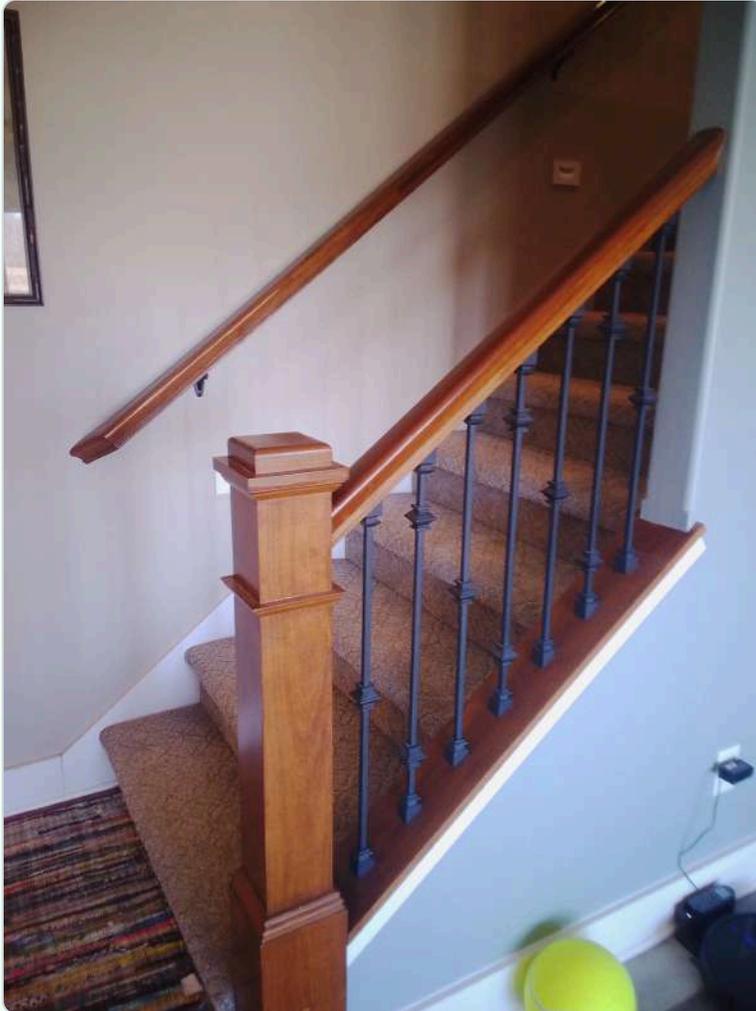
All railings are wood with metal attachments snug fit properly and are correct height

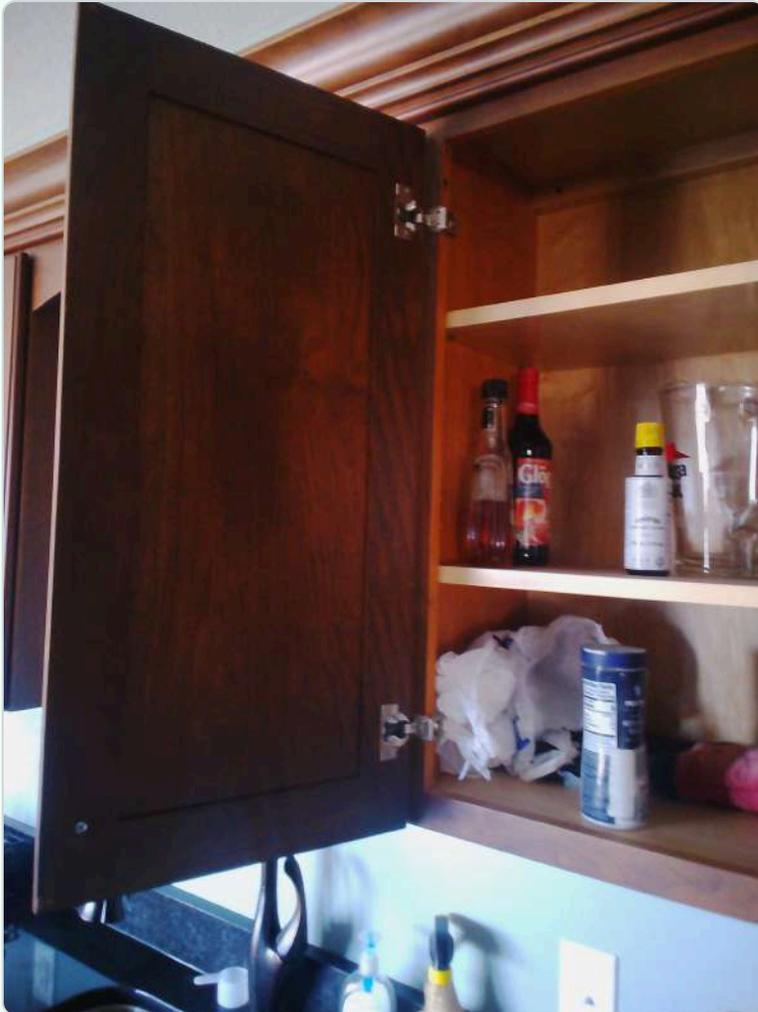
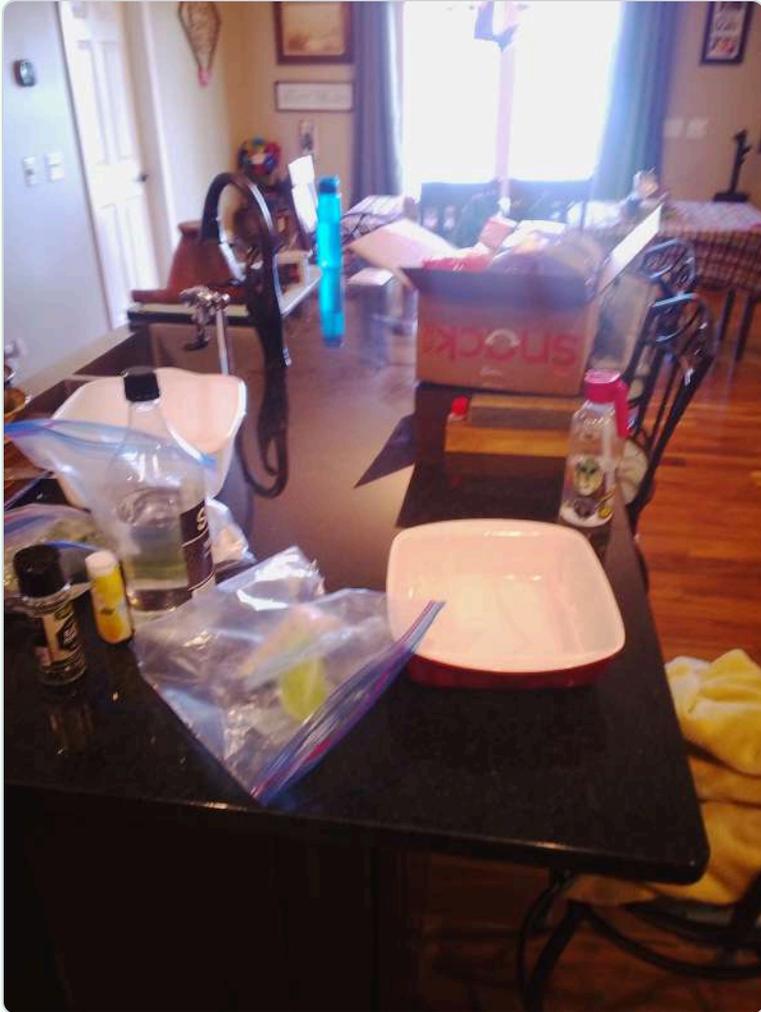
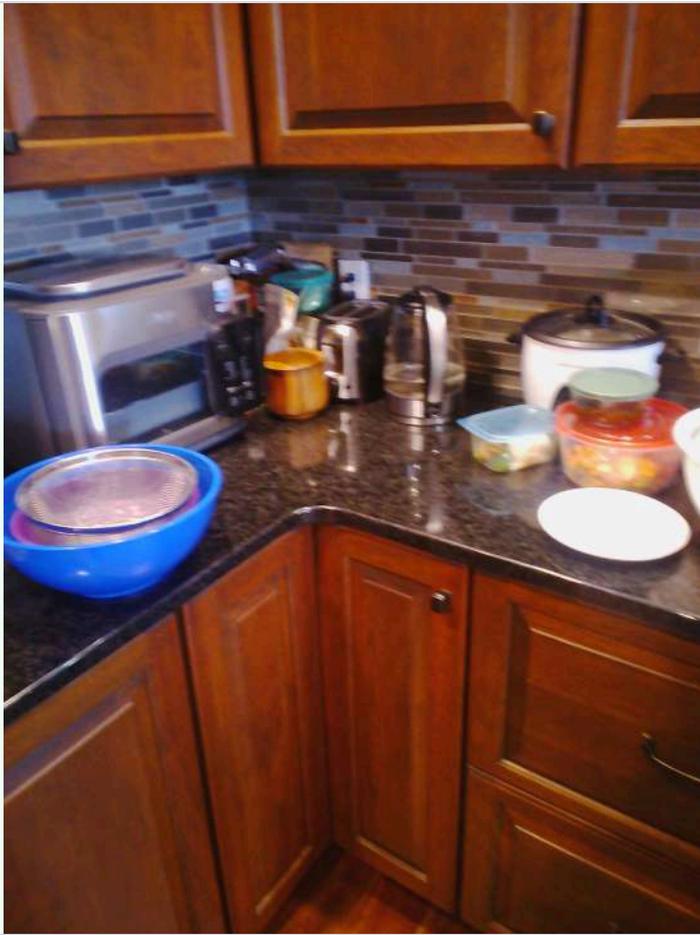
Countertops are granite no cracks no defects installed properly.

All cabinets are wood. Operate properly fastened properly no defects and good conditioner

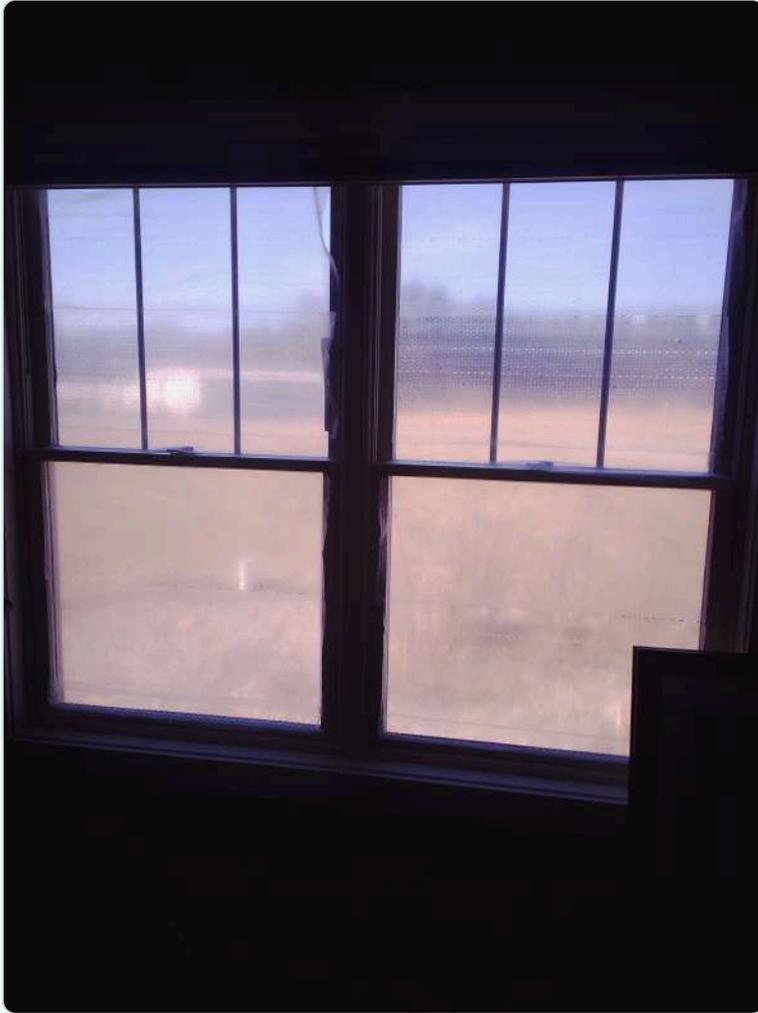
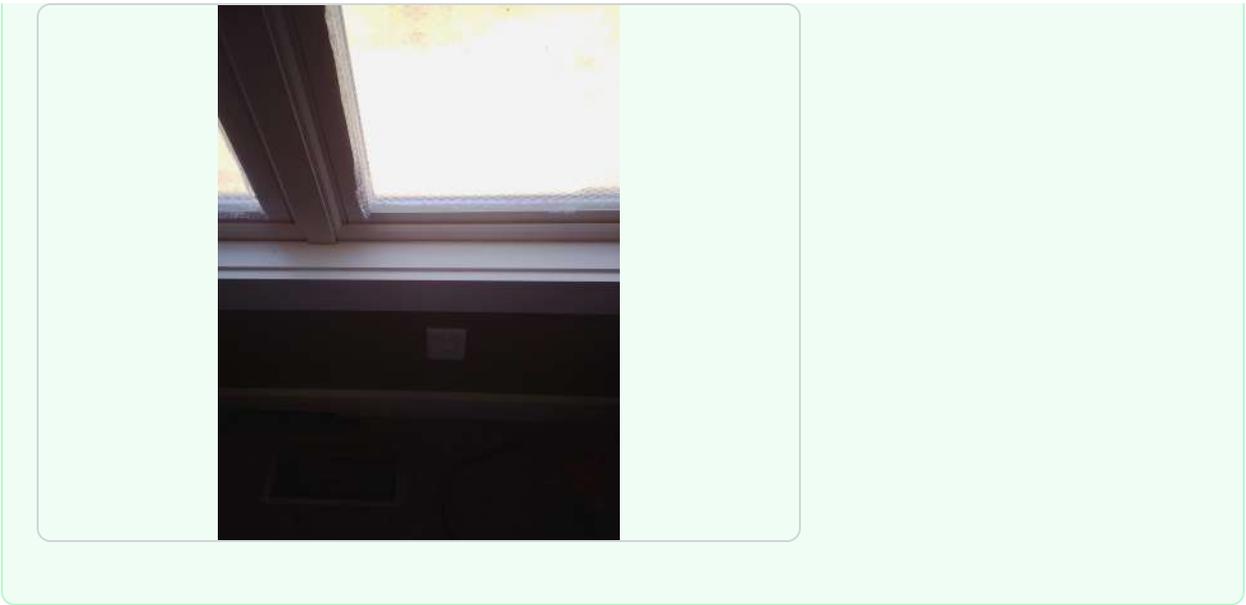
Due to some windows have plastic they are not open for tested

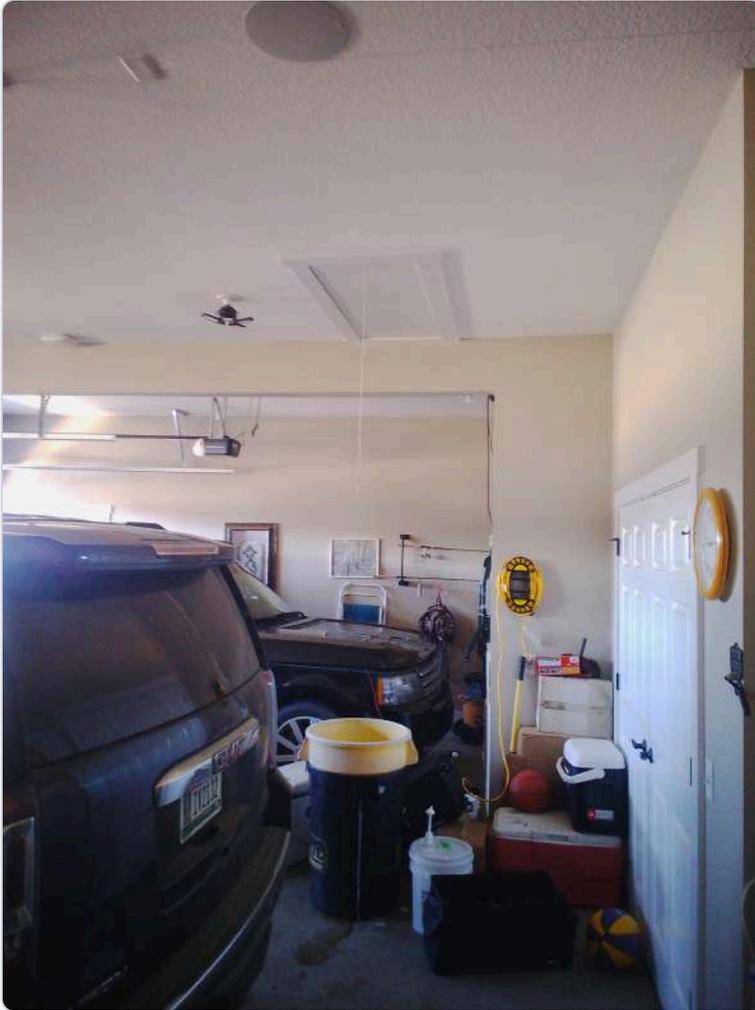
Not inspected due to items in the way.  
Car in the way of doorway.

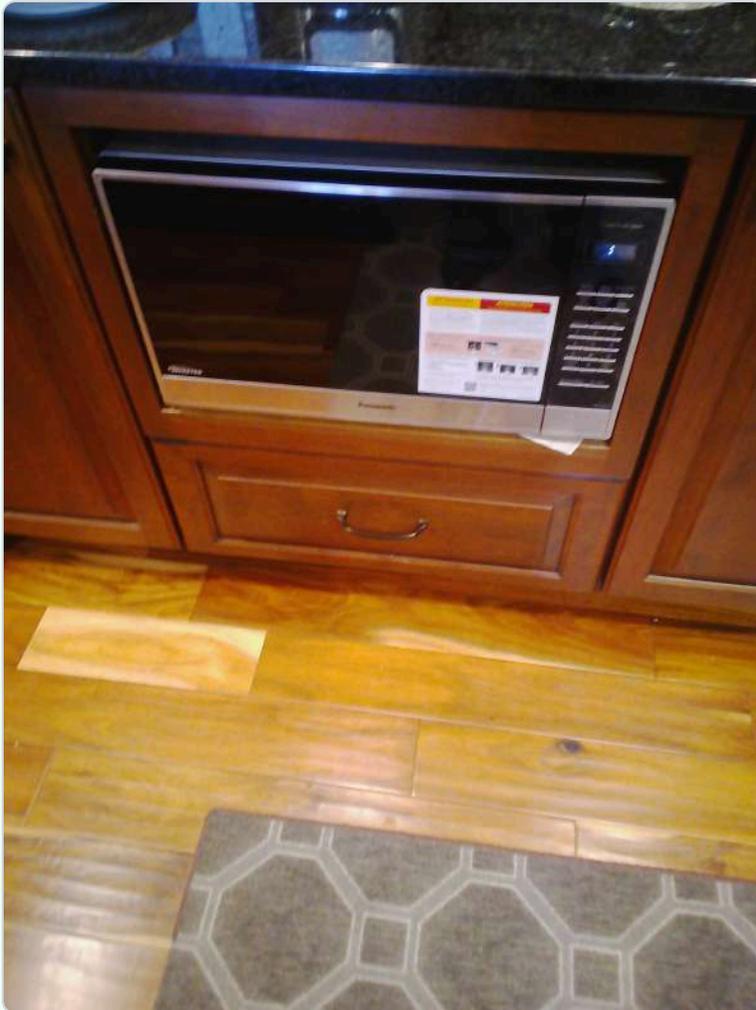
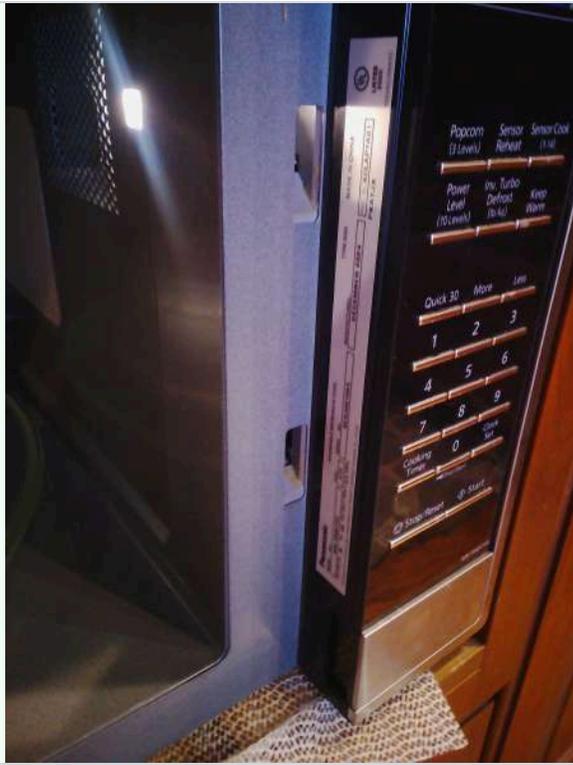
Panasonic model number nn-sn975s manufactured in December 2024

The microwave appears to be in satisfactory condition; however, it is recommended to verify proper operation during use and schedule routine maintenance as recommended by the manufacturer. Ensure the unit is regularly cleaned and inspected for any signs of wear or damage.

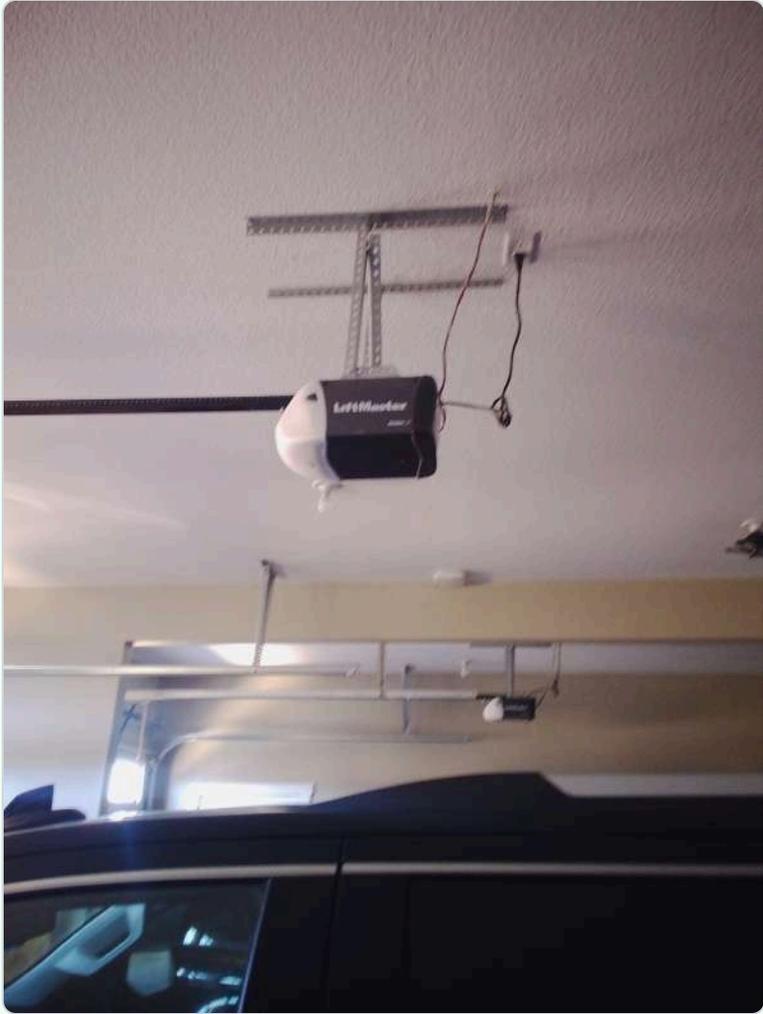
Operated by owner operates good safety stop does work.

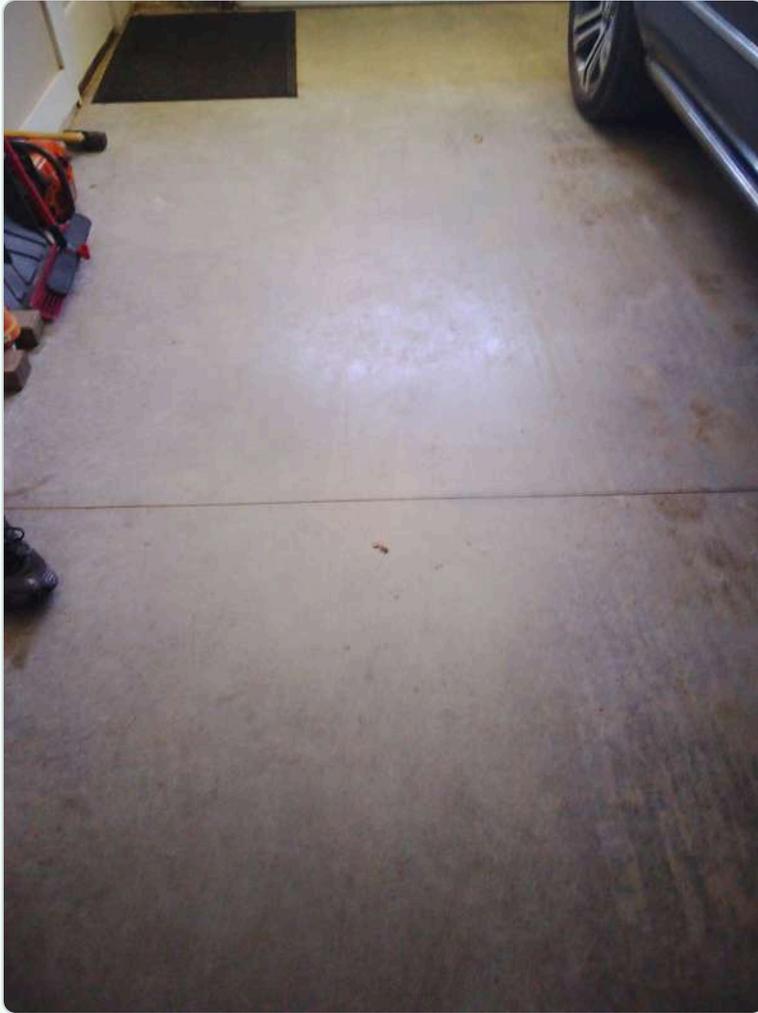
Garage floor is concrete with drain no cracks and concrete no defects found.

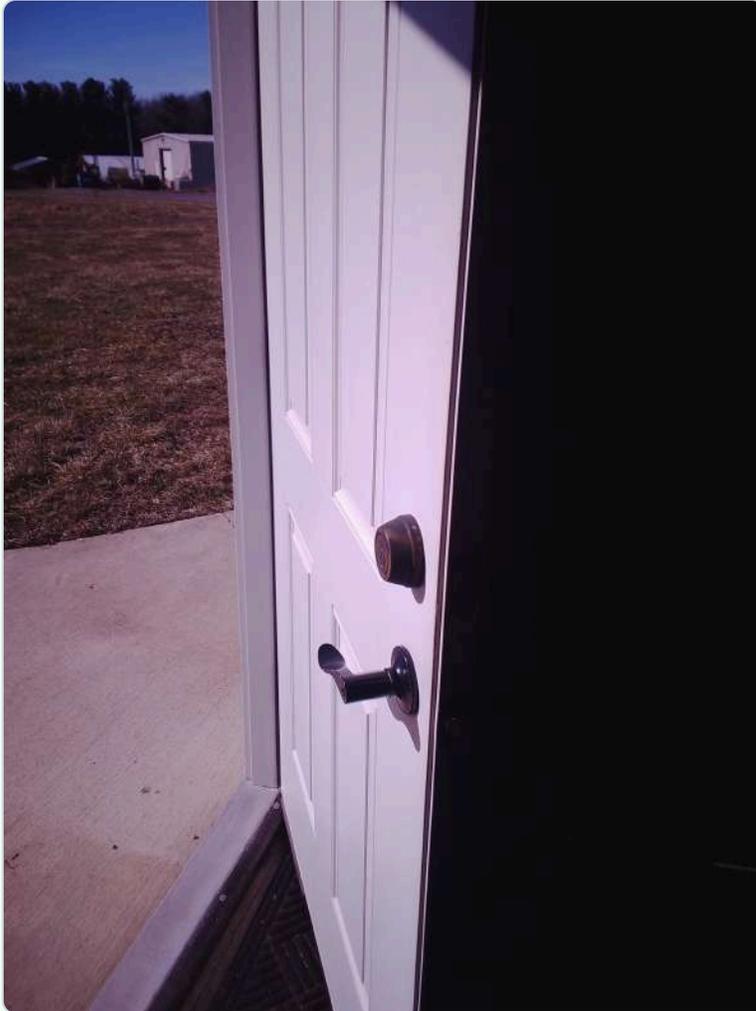
Service door to the outside properly works closes opens no defects found.

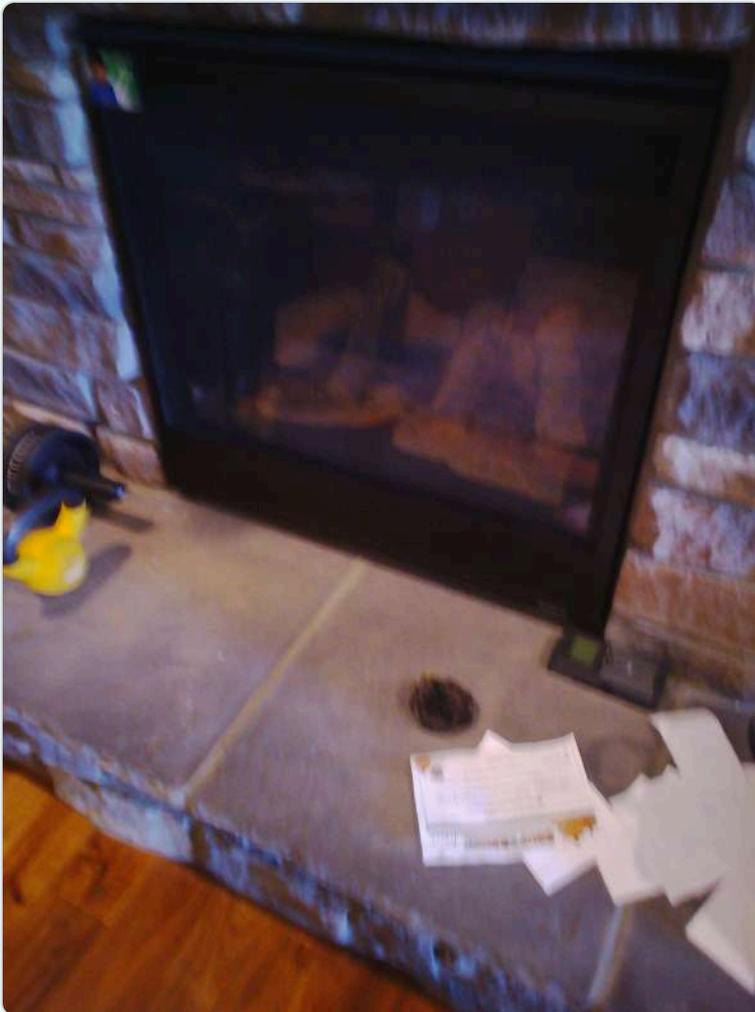
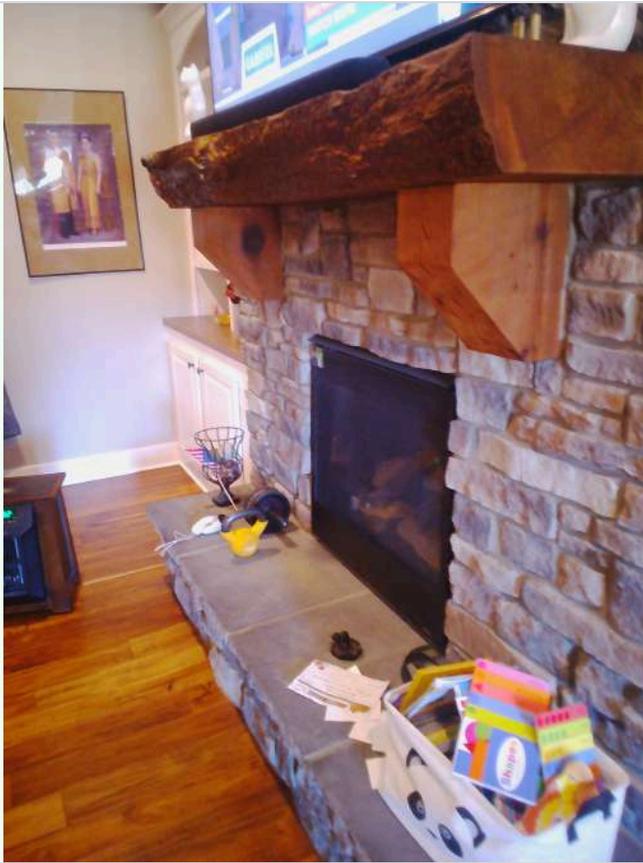
Fireplace is gas. Properly functional and operational per owner not tested by inspector

The gas fireplace appears to be properly installed and operational; however, it has not been tested during this inspection. It is recommended that a qualified technician conduct a thorough safety and functionality test to ensure proper operation and safety.

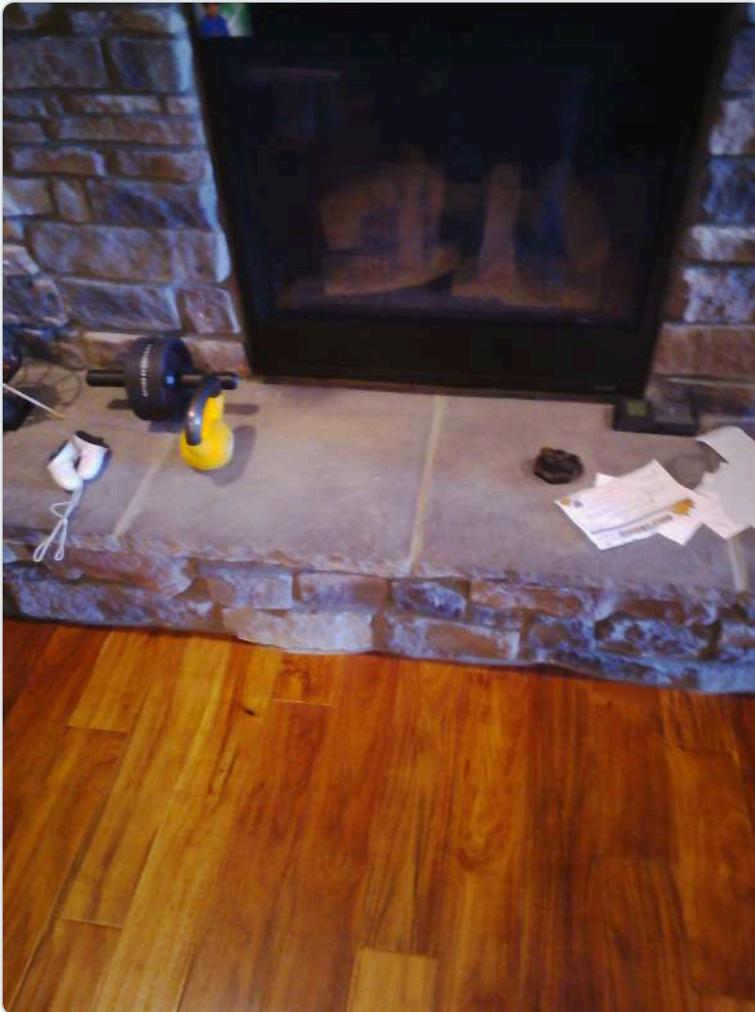
Over 12 in wide and good condition

The hearth and mantle are over 12 inches wide and in good condition; no immediate concerns are noted. Continue regular maintenance and inspections to ensure ongoing safety and stability.
