## AP Inspections LLC

Report Number  
**INS-2026-0010**  
3/1/2026

**9480 east 200 north**  
Fremont, IN 46737

Inspection Date: 3/1/2026

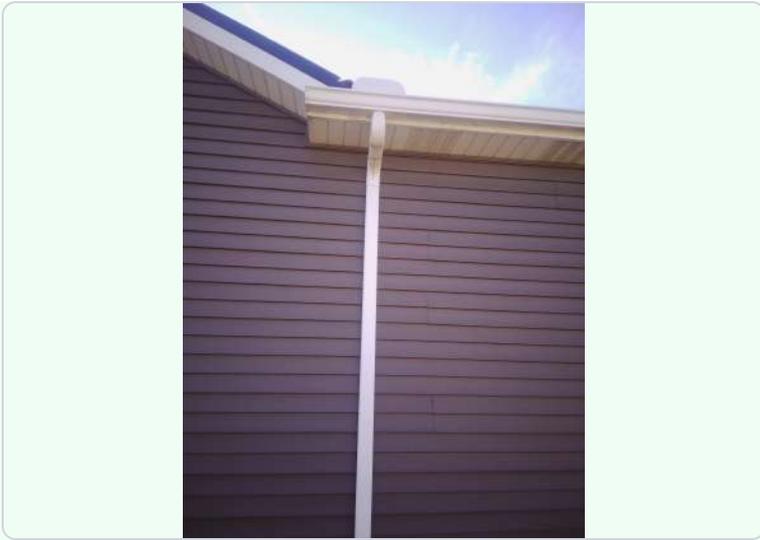
## Gutters & Downspouts

Underground drainage

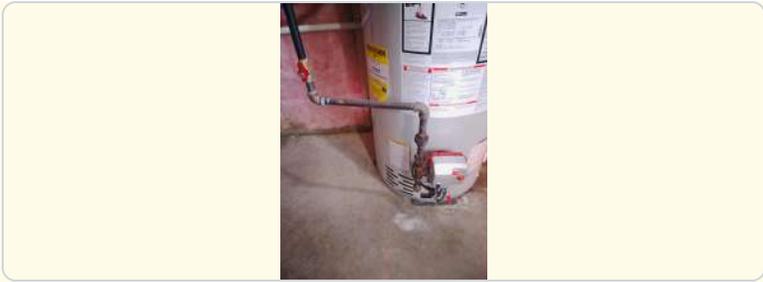
No restraints visible trp valve leaks

Recommend a qualified plumber evaluate the water heater restraints to ensure proper installation and safety. Additionally, have a professional inspect the temperature and pressure relief (TRP) valve for leaks or signs of malfunction.

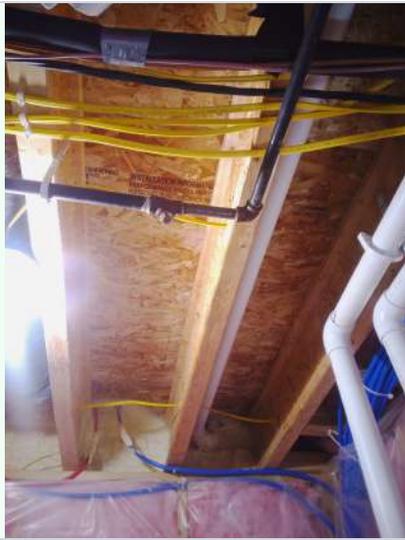
## Fuel Service & Piping (if present)

All fuel propane piping looks good no rust with shut off valves

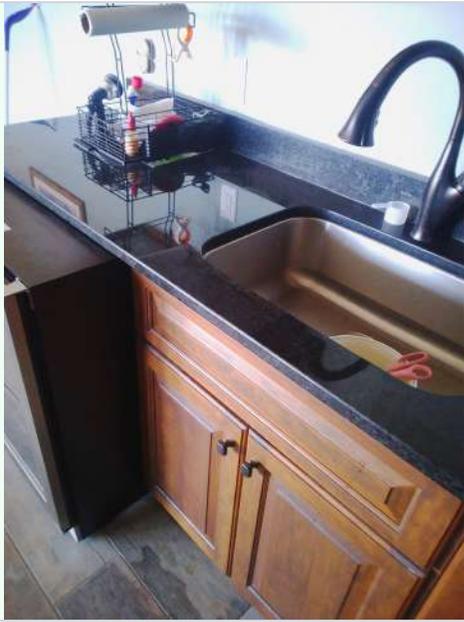
## Countertops & Cabinets

Countertops are granite no cracks no defects installed properly.

All cabinets are wood. Operate properly fastened properly no defects and good conditioner

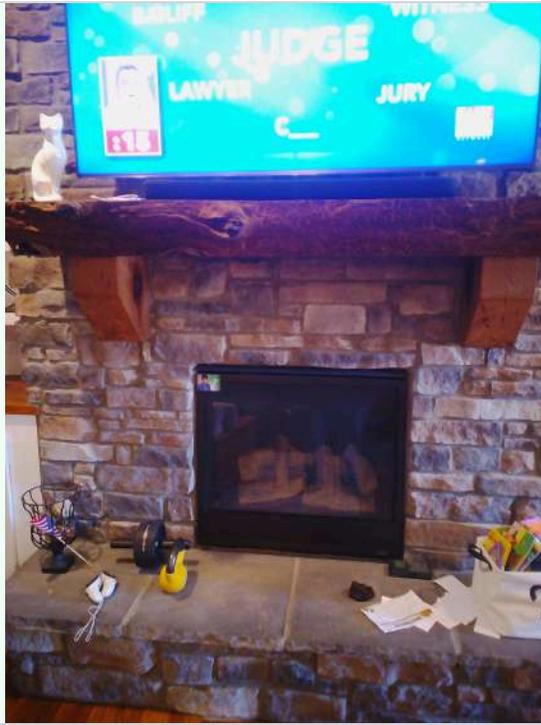
Over 12 in wide and good condition

The hearth and mantle are over 12 inches wide and in good condition; no immediate concerns are noted. Continue regular maintenance and inspections to ensure ongoing safety and stability.
